Airworthiness Directive

Amendment 39-3810; AD 80-14-03

Airworthiness Directives; Piper Model PA-28-161, PA-28-181, PA-28-201T, PA-28-236, PA-28R-201, PA-28RT-201, PA-28R-201T, PA-28RT-201T, PA-32-260, PA-32-300, PA-32-301, PA-32-301T, PA-32R-300, PA-32RT-300, PA-32RT-300T, PA-32R-301, PA-32R-301T, PA-34-200T and PA-44-180 Airplanes

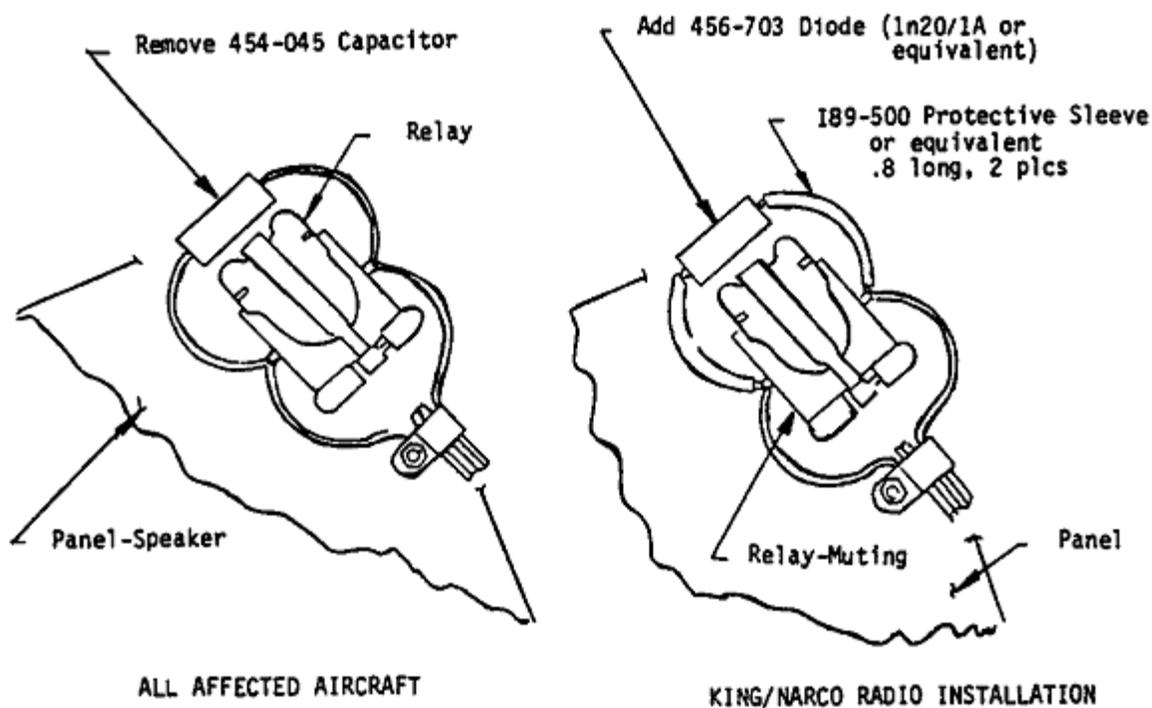
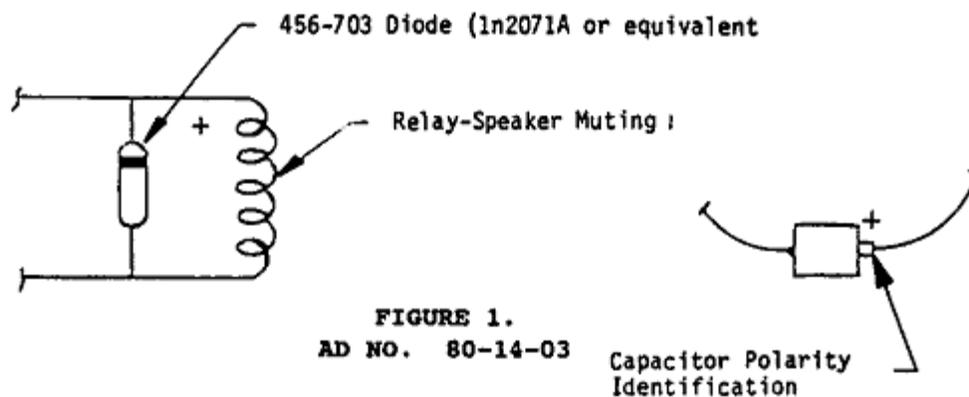
FIGURE 1.
AD NO. 80-14-03

Capacitor Polarity
Identification

(2) Remove the 22 mfd capacitor, part number 454-045, soldered to the muting relay, noting polarity, and install diode as shown in figure 1. Diode is not required on Bendix avionics systems.
