The New Piper Aircraft, Inc.
 2926 Piper Drive
 Vero Beach, Florida, U.S.A. 32960

SERVICE No. 1156 BULLETIN

Date: April 7, 2005

PERIODIC REPLACEMENT OF NOSE GEAR DRAG LINK BOLT

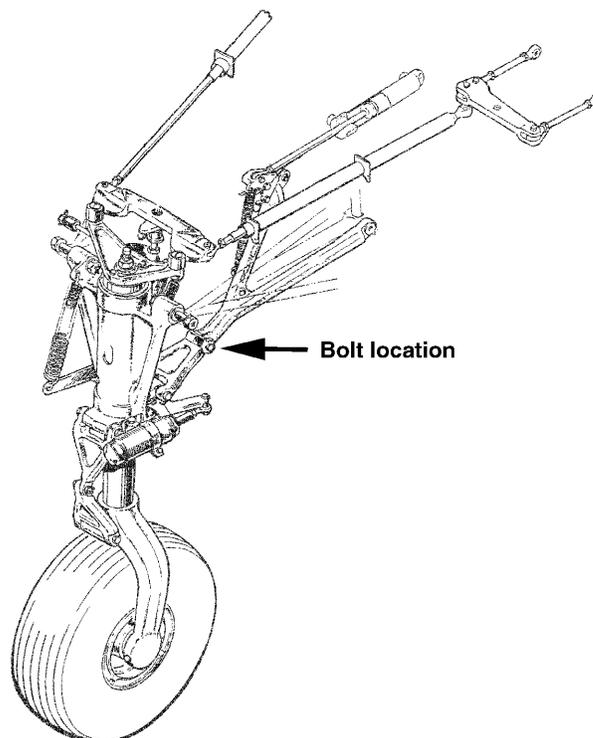
Figure 1
Typical PA-28R Bolt Location

It has been determined that, under certain conditions, the bolt that fastens the Upper and Lower Nose Gear (NG) Drag Links can develop wear in a manner that may not be detectable during routine maintenance and inspection. Specifically: on some aircraft, score marks have been discovered around the circumference of the bolt shank, midway along the length of the bolt.

By design, the bolt is free to rotate inside a set of bushings to allow relative movement between the Upper and Lower Drag Links during Landing Gear extension and retraction. Over an extended number of operating hours, this rotation can generate the score marks described, causing stress concentrations to develop in the bolt.

Left uncorrected, this condition could eventually result in bolt failure, with subsequent Nose Gear collapse.

1. Jack the aircraft per the Aircraft Service Manuals/Maintenance Manuals.
2. Disassemble Upper Drag Link from Lower Drag Link, by removing the NAS464P4-27 bolt that functions as a hinge pin for the two parts. See Figure 1 or Figure 2 as applicable. Discard bolt and cotter pin, regardless of condition. Nut and washers may be reused, depending on condition.

3. Inspect bushings for excessive wear, and verify that bushing IDs are within Service Dimension range of .2515 to .2495 inches, replacing as necessary.

4. Reassemble Upper and Lower Drag Links per the Aircraft Service Manuals/Maintenance Manuals, by installing a new NAS464P4-27 bolt, taking care to reposition washers retained in Step 2. Reinstall castellated nut retained in Step 2. and secure with a new MS24665-134 cotter pin.
