# SERVICE NO. 1251 BULLETIN

Date: April 10, 2013 (S)

**STABILATOR TRIM BARREL INSPECTION**

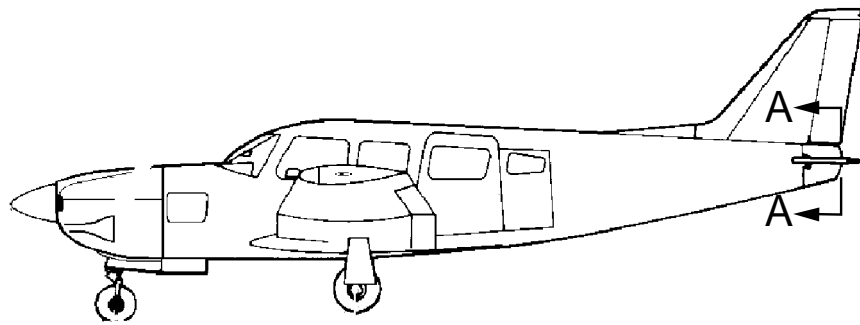
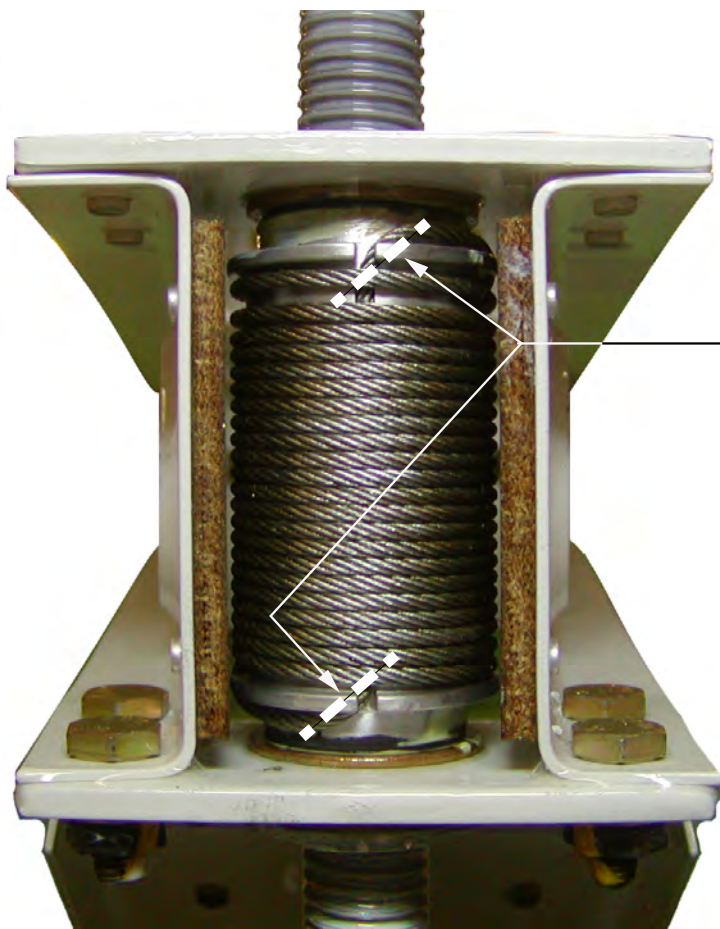
Figure 1

2. Identify the stabilator trim barrel and examine the routing of the stabilator trim cable at the locations shown in Figure 1. Additionally, compare the installed trim barrel against the CORRECT and INCORRECT trim barrel details shown in Figure 2.

Rear view of correct stabilizer trim barrel, with cable properly routed.

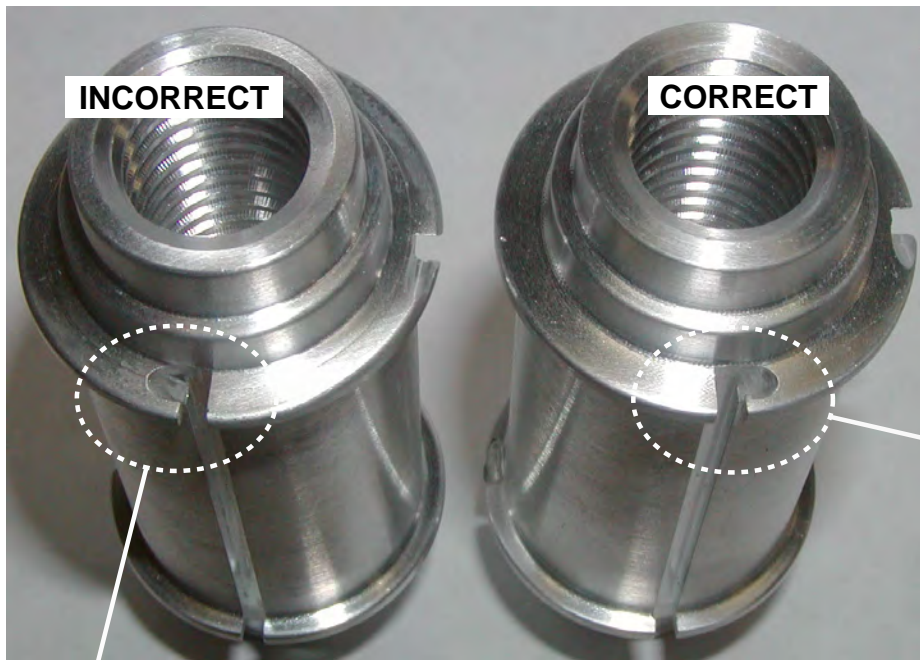
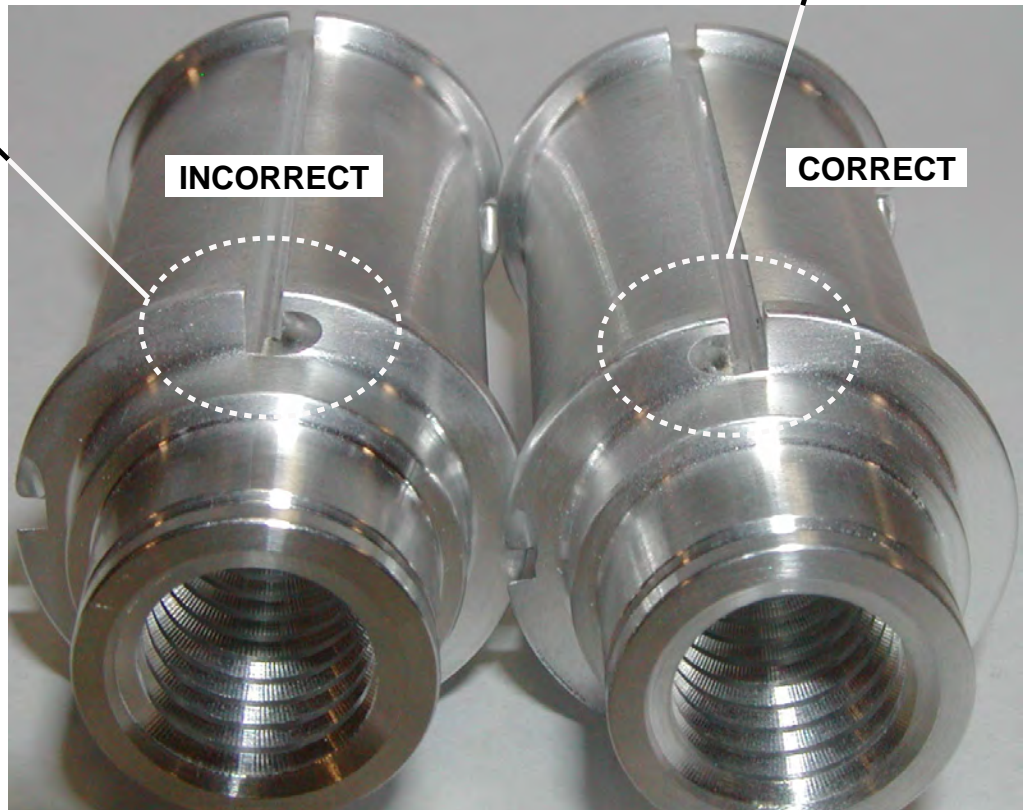
Figure 2

Left uncorrected, an incorrect stabilator trim barrel could lead to accelerated wear and eventual failure of the stabilator trim cable.

**NOTE:** A correct trim barrel is distinguished by visual examination of the stabilator trim cable at the locations where the cable passes through the slots in the upper and lower flanges of the trim barrel. A correct trim barrel will feature diagonally machined grooves in the flange to accommodate the cable routing. The installed cable is nested into these grooves, reducing cable strain. An incorrect trim barrel will have these diagonally machined grooves located on the opposite side of the slot from the cable routing.

Dashed lines identify correct geometry of diagonally machined grooves in the stabilator trim barrel flanges.

**INCORRECT** geometry of diagonally machined grooves in the stabilator trim barrel flanges.

- If the geometry of the stabilator trim barrel matches the illustrations marked "CORRECT" in Figure 2, then the stabilator trim barrel is acceptable for continued use. Reinstall the tailcone access panel, and proceed to Part IV.
- If the geometry of the stabilator trim barrel matches the illustration marked "INCORRECT" in Figure 2, replacement of the stabilator trim barrel and aft stabilator trim cable is required. Proceed to Part III.

1. Order replacement stabilator trim barrel, as well as replacement aft stabilator trim cable. Refer to the MATERIAL REQUIRED section of this service bulletin for the appropriate replacement part numbers.
2. Using instructions in the appropriate maintenance manual, remove the incorrectly manufactured stabilator trim barrel and aft stabilator trim cable. Return both parts to Piper for examination.
3. Using instructions in the appropriate maintenance manual, install, rig and adjust the new stabilator trim barrel and aft stabilator trim cable.
4. Reinstall the tailcone access panel, and proceed to Part IV.
