SERVICE BULLETIN

No. 548

Piper Aircraft Corporation

Subject: Engine Control Rod End Bearing Inspection

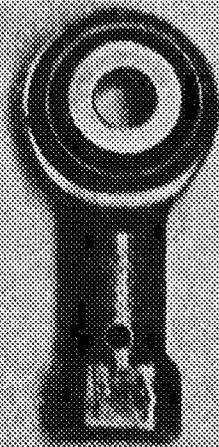
1

Purpose: It was found that the rod end bearing (Mfr. No. AHM 3LS or AHFT3-Piper Part No. 452 557) used on the Throttle, Mixture, and Prop Control Cables of some of the above referenced aircraft, will become extremely tight in cold weather due to contraction. Tightening of the bearing could impede the proper operation of these controls.

Note "raised" ball retainer

- b. If a rod end bearing - identified in the attached picture as number one (1) with a raised ball retainer is installed, it must be removed and replaced with a bearing listed in the Material Required, below. (Refer to the appropriate Piper Service Manual for proper replacement and rigging instructions.) Make appropriate log book entry and return the aircraft to service.

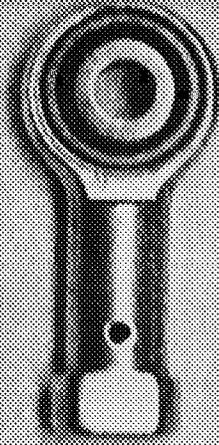
2

1. Gain access to the engine by opening or removing the cowling as required to conduct inspection.
2. Inspect the rod end bearing attached to the Mixture Throttle and Prop Governor (if applicable) Control Cables. (Refer to the picture attached to this Service Release.)
 - a. If a rod end bearing as identified in the picture as number two (2) (Brass Ball Retainer) or as number three (3) (Silver Ball Retainer) is installed then no

2. a. (continued)
further action is required. Make appropriate log book entry and return aircraft to service.
