SERVICE BULLETIN

No. 681

Piper Aircraft Corporation

Boom Microphone Isolation Relay

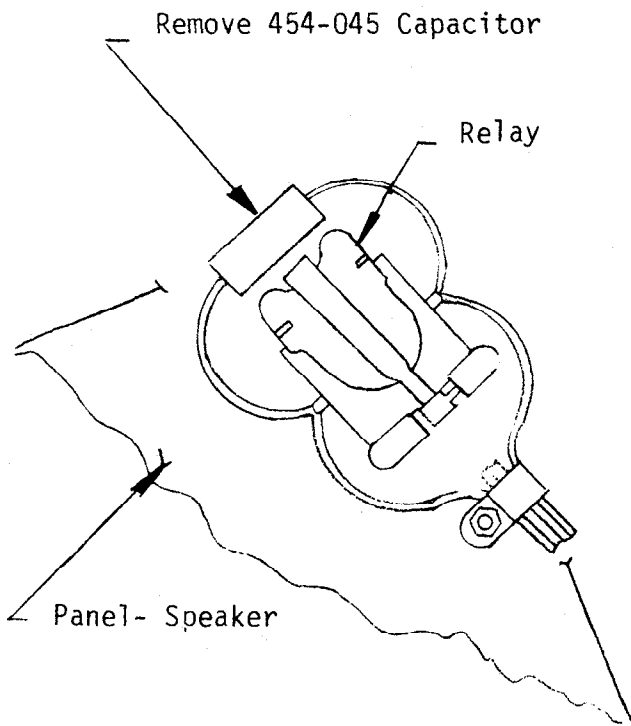
ALL AFFECTED AIRCRAFT

3. Locate the muting relay mounted on the speaker grill or speaker and the 22 mfd capacitor soldered to the relay.

4. Using proper soldering techniques:
 - A. Remove the capacitor, and on King and Narco avionics systems, install diode 1N2071A (Piper Part Number 456-703).
 - B. Diode is not required on Bendix avionics systems.
5. If Part 1 was previously accomplished, reconnect the muting relay plug and conduct radio check for proper operation.

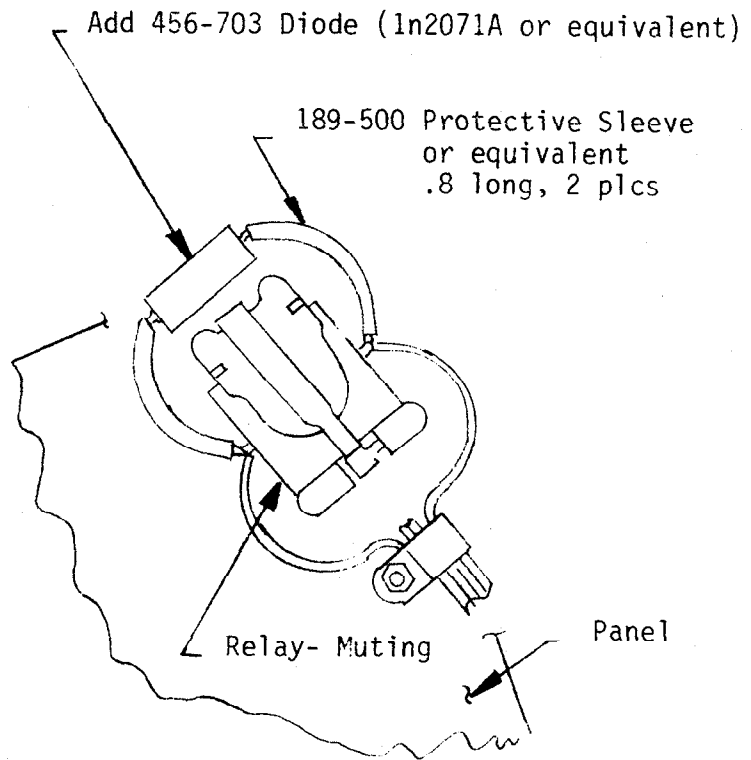
KING/NARCO RADIO INSTALLATION

IMPORTANT: When removing capacitor, note polarity marked on shell and install diode relative to this polarity as shown in sketch 1.
