Piper Aircraft Corporation
Vero Beach, Florida, U.S.A.

SERVICE No. 811A
BULLETIN

May 12, 1986

Ammeter Replacement

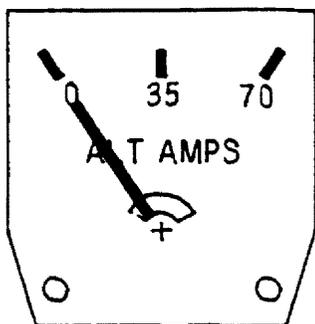
SKETCH "A"

PURPOSE: Engineering tests have determined that a number of ammeter gauges shipped in support of Service Bulletin No. 811 were not correctly calibrated. Correctly calibrated gauges may be identified by the presence of a white dot located on the righthand side of the ammeter face, immediately following the word "AMPS". See Sketch "A" attached. Incorrect ammeter indications could lead to inadvertent overcharging and/or depletion of the aircraft's battery with subsequent loss of battery electrical power.

AMMETER THAT HAS NOT
BEEN CALIBRATED.
NOTE ABSENCE OF IDENTIFICATION DOT

1. All aircraft which have complied with Service Bulletin No. 811 must inspect for the presence of a white dot on the righthand side of the ammeter face. See Sketch "A" attached.
2. If white dot is not present, the ammeter gauge, only, must be replaced with a correctly calibrated gauge.
3. Using applicable instructions for the Ammeter Replacement Kit, Piper Part Number 765-186, replace the newly installed ammeter only, with Ammeter, Piper Part Number 763-053.

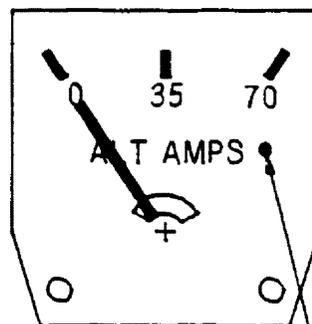
AMMETER THAT
HAS BEEN CALIBRATED
IDENTIFICATION DOT
