**Piper Aircraft Corporation**  
2926 Piper Drive  
Vero Beach, Florida, U.S.A. 32960

# SERVICE No. 977 BULLETIN

DATE: December 12, 1994

**Inspection of Wing Rear Attach Fitting  
and Addition of Inspection Access Panels.**

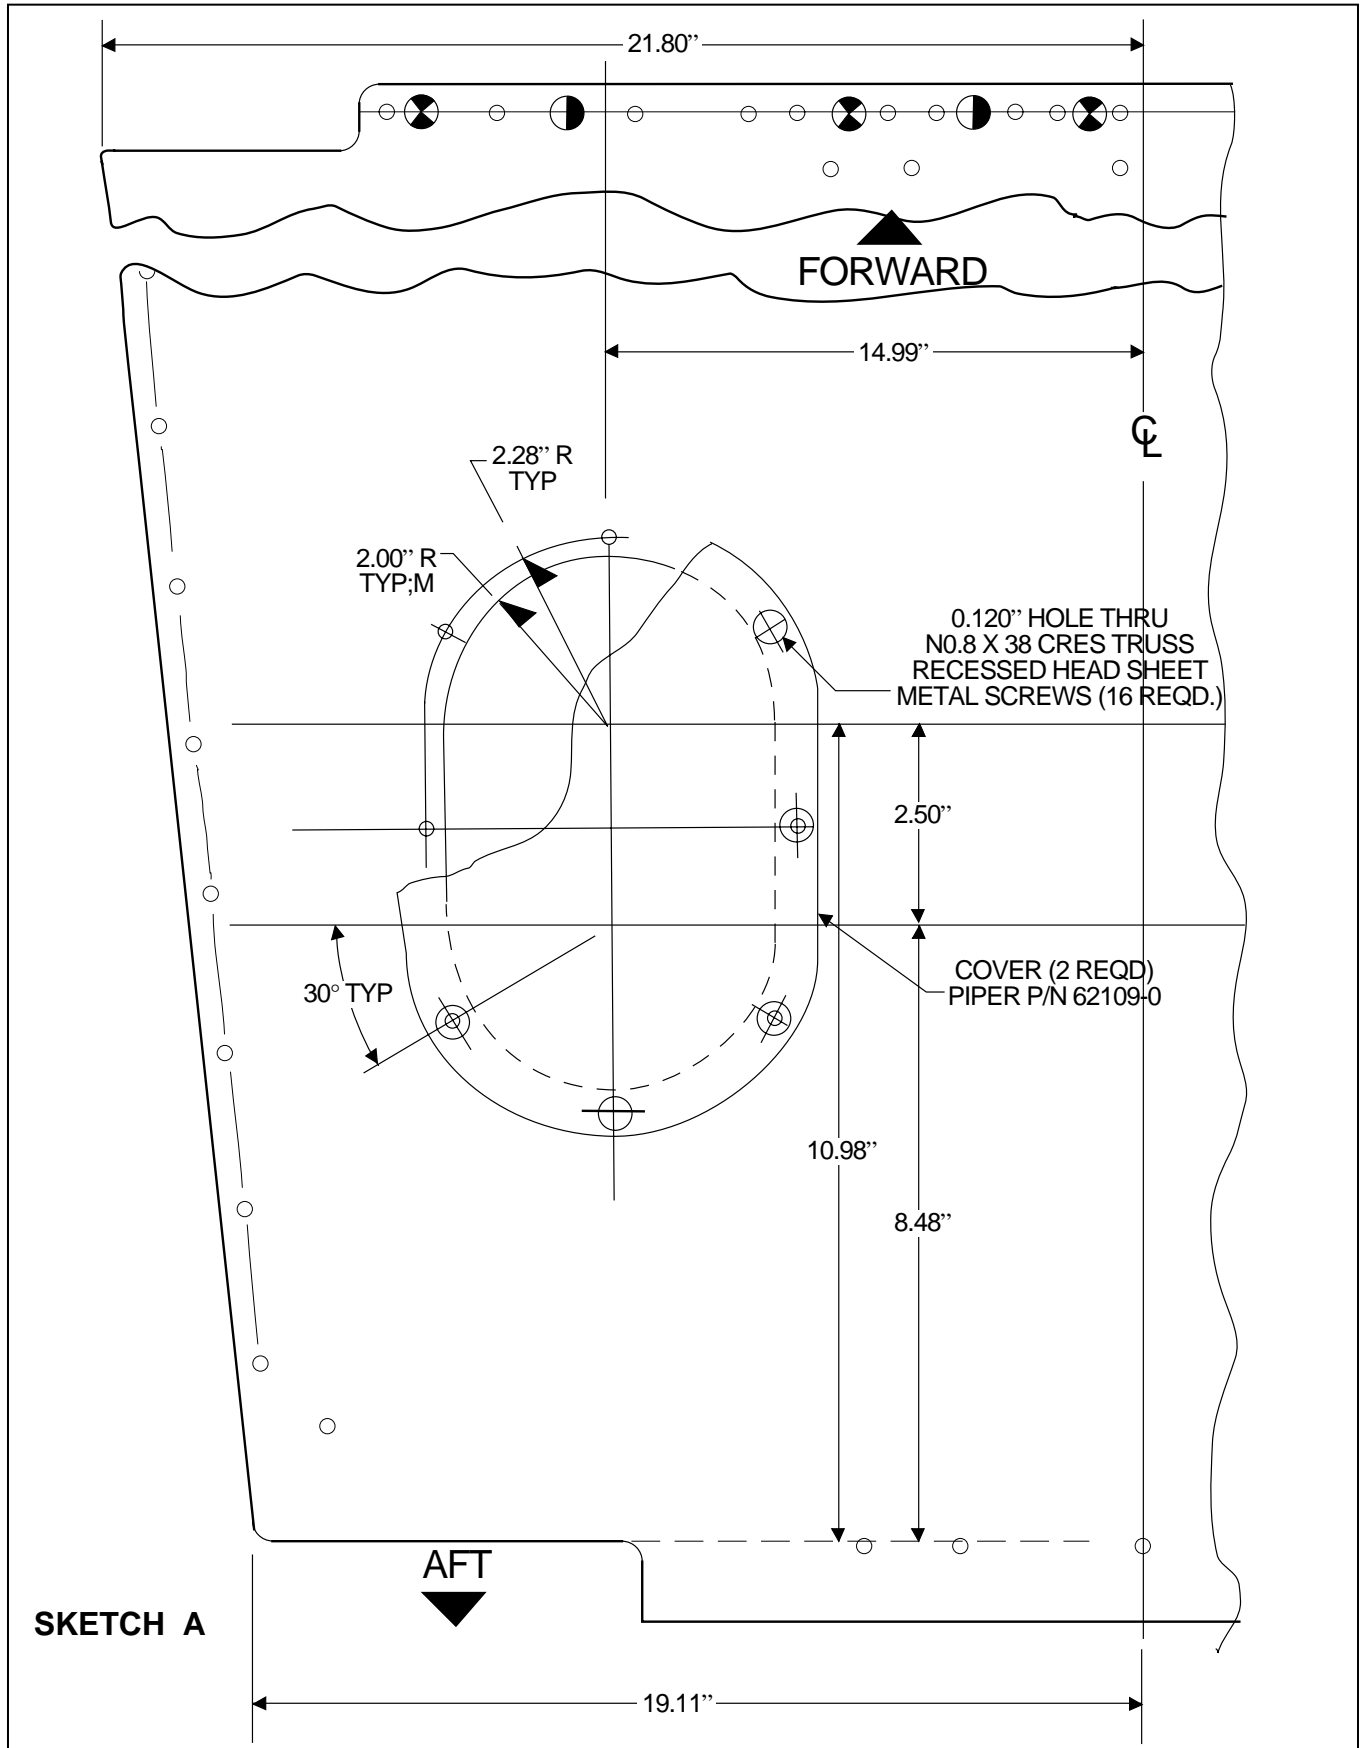
**INSTALLATION OF INSPECTION ACCESS  
PANELS IN PA-28/44 SERIES AIRCRAFT****Baggage Compartment Inspection Holes Fabrication Procedure (Refer to Sketch A)**

While Sketch A shows the hole in the left side of the baggage compartment, a similar hole is also cut out in the right side baggage compartment floor. Installation will require two each inspection access covers, Piper P/N 62109-0. (If desired, these covers may be fabricated locally.)

- (4) Measure two points 14.99 inches each side of the reference centerline. Joining these two points will form the centerlines of each inspection hole.

- (5) Measure two points on each side of each centerline of both holes at distances of 8.48 inches and 10.98 inches from the aft edge of the baggage compartment floor.

- (6) Connect the two 8.48" points and the two 10.98" points so that the resulting lines cross the centerline of each hole.
  - (7) Using the intersection of the lines constructed in step (6) with each hole's centerline as the center, scribe an arc having a radius of 2.00"

- (8) Draw a line (four lines total) tangent to the each side of the arcs constructed on step (7).
  - (9) There should now be two ovals, like the one in Sketch A, laid out on each side of the baggage compartment floor.

- (1) Drill a 1/4 inch hole inside of, and adjacent to, one of the scribed lines layed out for each hole.
  - (2) Using a 1/8 inch router bit, cut out the two inspection holes by following the lines layed out on each side of the baggage compartment floor.
  - (3) Deburr each cut edge using a file or emery wheel.
- c. Installing covers.
    - (1) Lay one of the 62109-0 covers over one of the inspection holes. Using the screw holes in the cover, scribe the position for the screw holes on the baggage compartment floor.
    - (2) Drill a 0.120 inch hole in baggage compartment floor at each position layed out in step (1).
    - (3) Attach cover to flooring with No.8 X 0.38 corrosion resistant steel sheet metal screws.
    - (4) Repeat steps (1) through (3) on remaining hole.
  - d. Install baggage compartment rear and side close out panels.
  - e. Install baggage compartment floor rug.

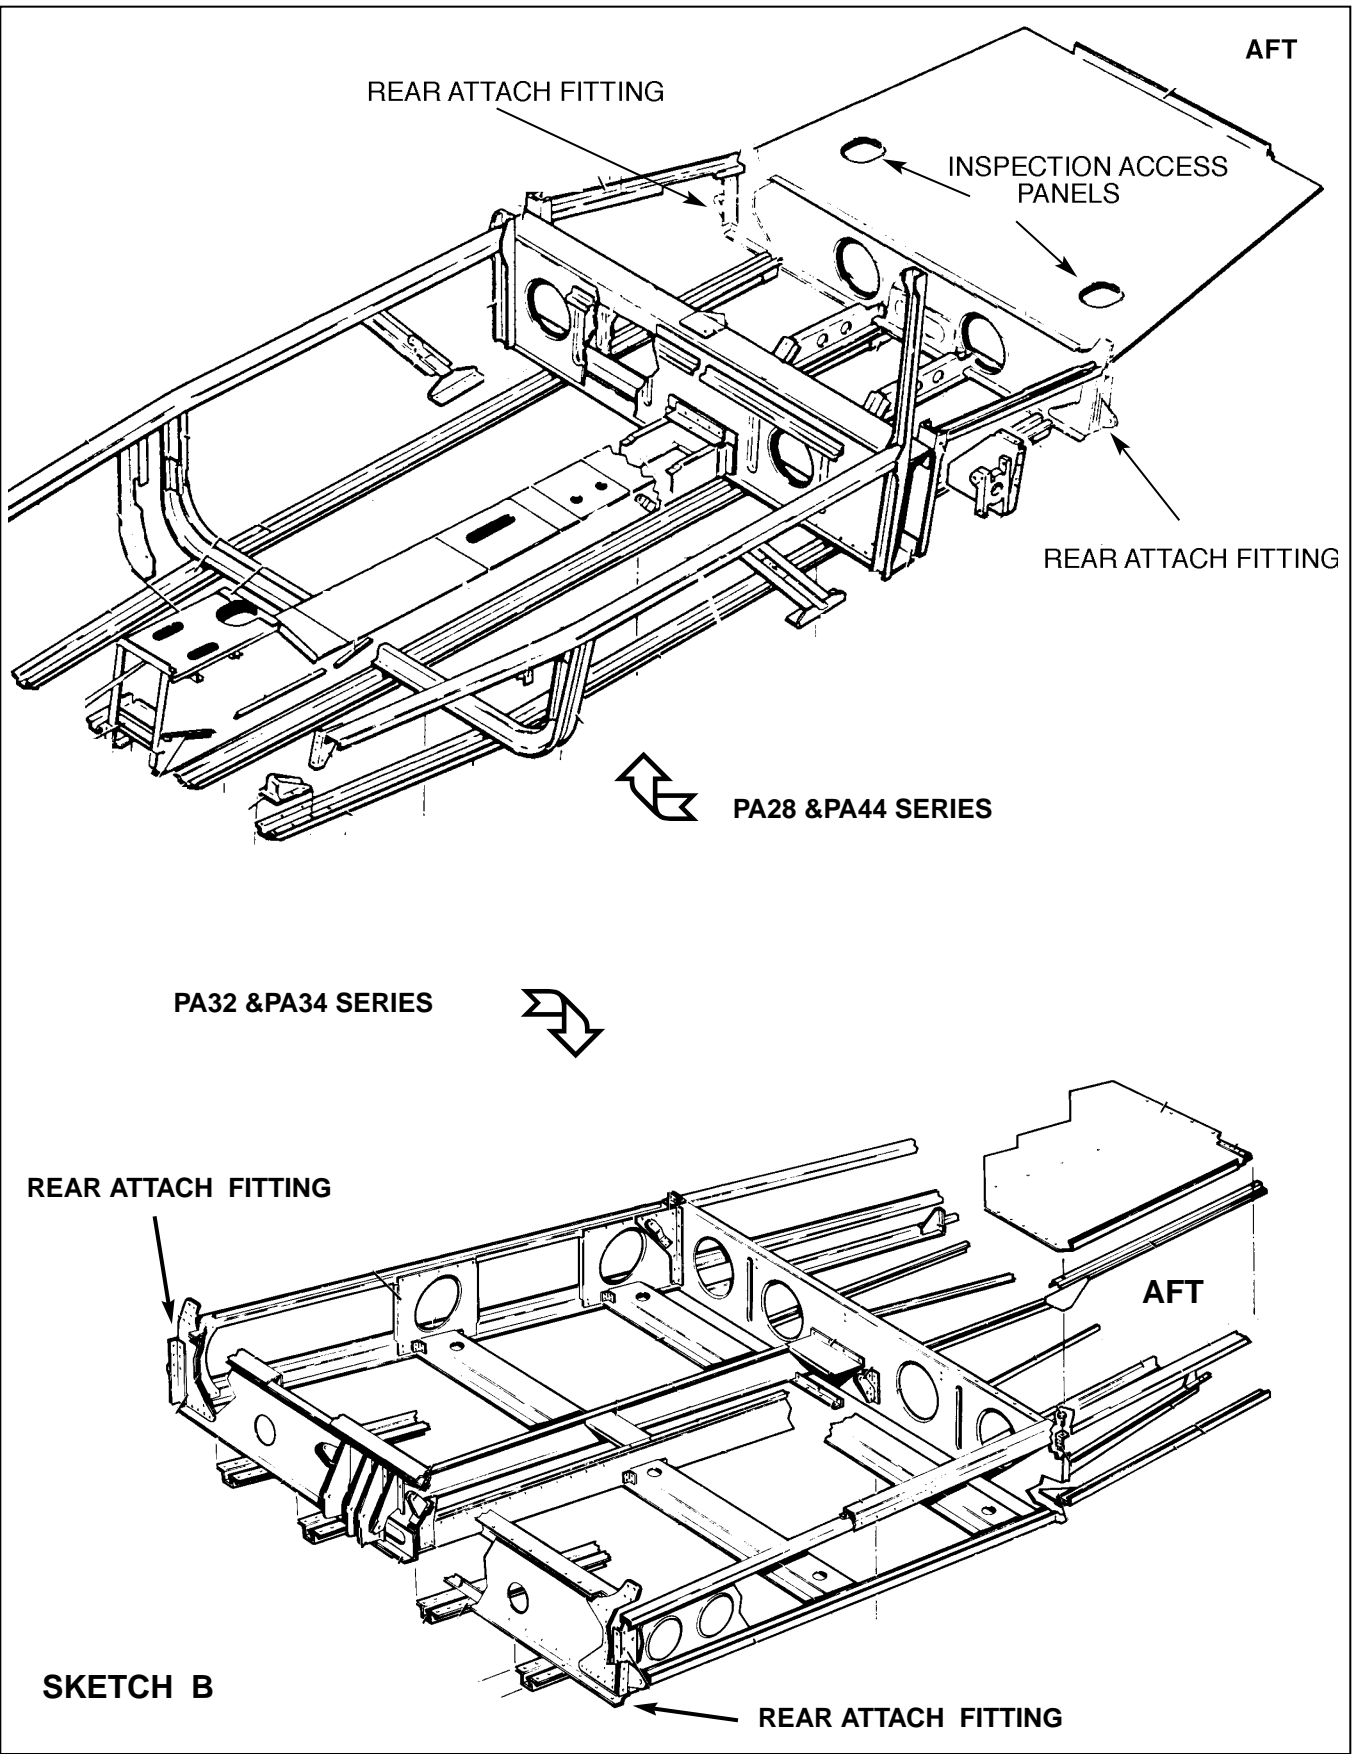
### REMOVAL AND RE-INSTALLATION OF REAR WING ATTACH FITTINGS (IF REQUIRED)

9. Clean and inspect the areas that were under bracket for any signs of corrosion.
10. If corrosion is found, repair or replace parts as necessary. Coat the area with primer and allow to dry.

6. Remove bolt from wing rear spar and fuselage attach fitting.
7. Carefully drill out the rivets that attach the fitting to the spar.
8. With all the rivets removed, remove wing attach fitting from the aircraft. Discard fitting.

11. If no corrosion is found, coat the area with primer. Allow time to dry.
12. Install new wing attach fitting and align rivet holes. It may be necessary to ream open the bolt hole to proper size. The hole is close tolerance and should be .3115 / .3135 (5/16) or .3745 / .3765 (3/8) depending on model and year. Replace attach fitting bolt should there be any sign of wear or corrosion.

13. Re-rivet wing attach fitting into place with appropriate fasteners. (See note at bottom of page.)
14. Install wing spar and fuselage attach fitting bolt per appropriate section of the Maintenance Manual.

15. Seal edges of attach fittings with PRC PR1422 (or equivalent) before installing interior.
16. Complete same process to the opposite side.
17. Reinstall cargo door floorboard and interior and seats. Connect battery and check for operation.
