Contains Useful Information Pertaining To Your Aircraft Engine

- SUBJECT:** Connecting Rod Bolt, (P/N 655959) and Crankcase Clearance Inspection
- PURPOSE:** To inspect connecting rod bolt/crankcase clearance after connecting rod bolt replacement.
- COMPLIANCE:** Anytime connecting rod assembly or connecting rod bolts are replaced, perform the inspections set forth in this Service Document prior to further engine operation.
- MODELS**
- AFFECTED:** All Continental Motors (CMI), IO-360 (except AF), and L/TSIO-360 aviation gasoline (AvGas) engines originally manufactured or rebuilt prior to 2011.

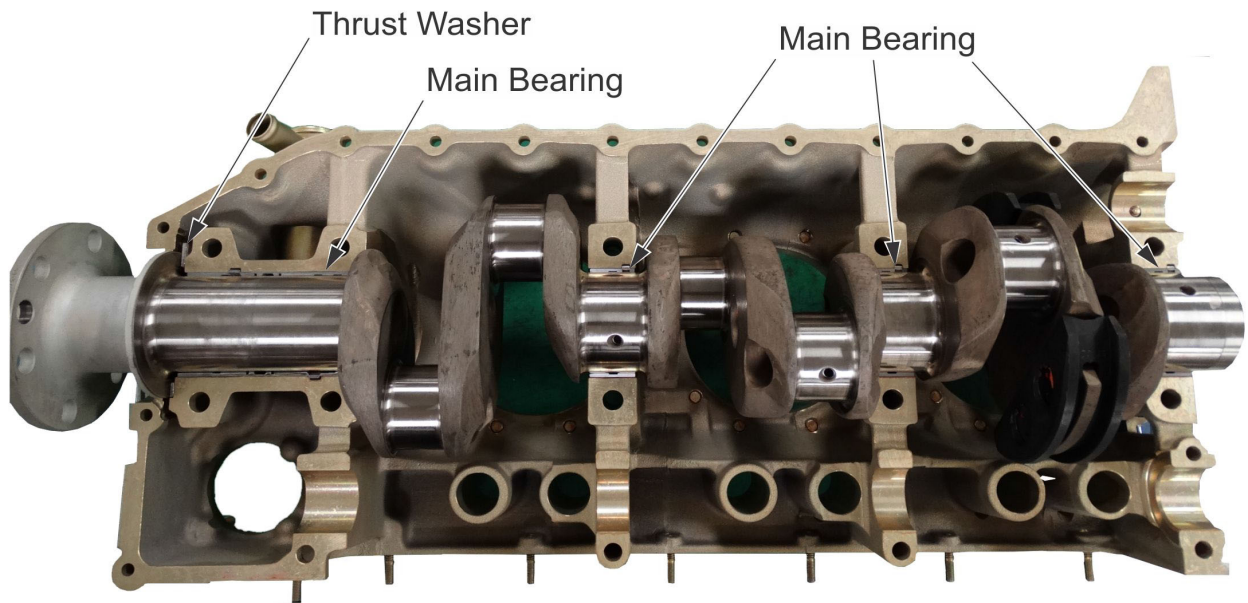
**Figure 1. Crankshaft, Main Bearings, and Thrust Washers, 1-3-5 side typical**

1. Before crankshaft assembly, place the 1-3-5 crankcase on it's side and install all bearings and thrust washers to support the crankshaft assembly. Lay crankshaft assembly on the main bearings in the crankcase half (see Figure 1).

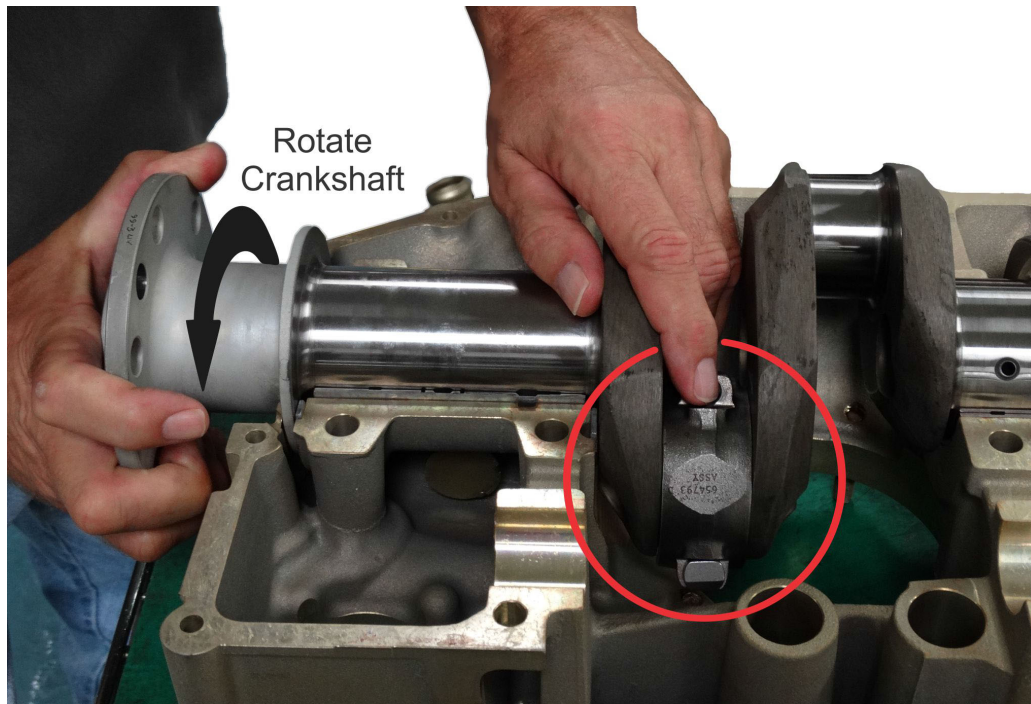
**Figure 2. Rotate Crankshaft, Connecting Rod Cap, Bearing and Bolt**

2. Insert the connecting rod bolt (with chamfer facing outward) into the connecting rod cap. Seat and hold the connecting rod (cap, bearing and bolt) assembly, over the first rod journal with connecting rod bolt head facing toward crankcase rib (see Figure 2).

3. Carefully rotate the crankshaft assembly in the 1-3-5 crankcase while simultaneously rotating (circumvolving) the connecting rod (cap, bearing, and bolt) assembly around the first journal to ensure the connecting bolt head achieves complete clearance past the crankcase rib.

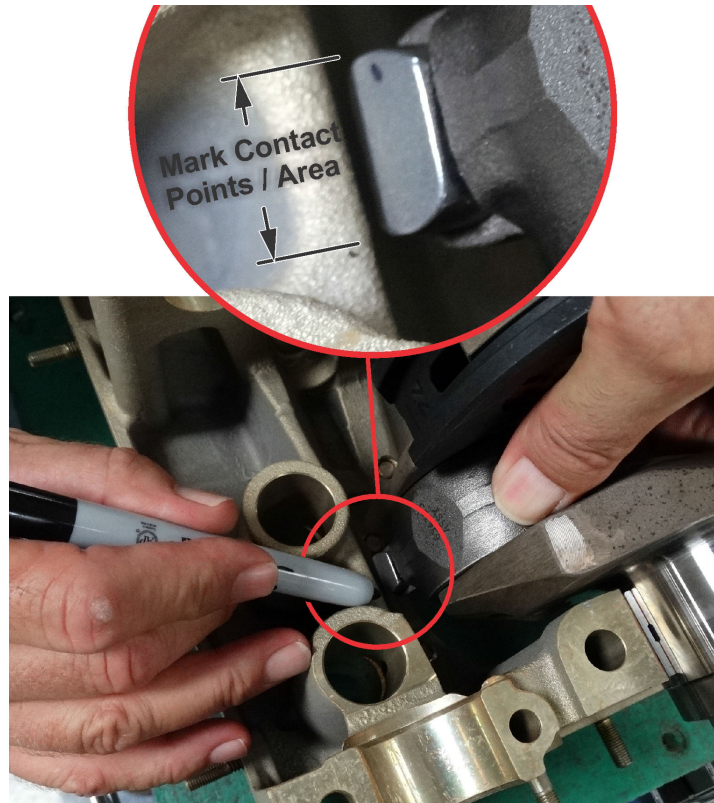
- If contact is made between the connecting rod bolt head and crankcase rib, mark the crankcase rib with a permanent marker on both sides of the bolt head (as shown in Figure 3).

**Figure 3. Mark Crankcase/ Bolt Head Interference Points / Area, typical**

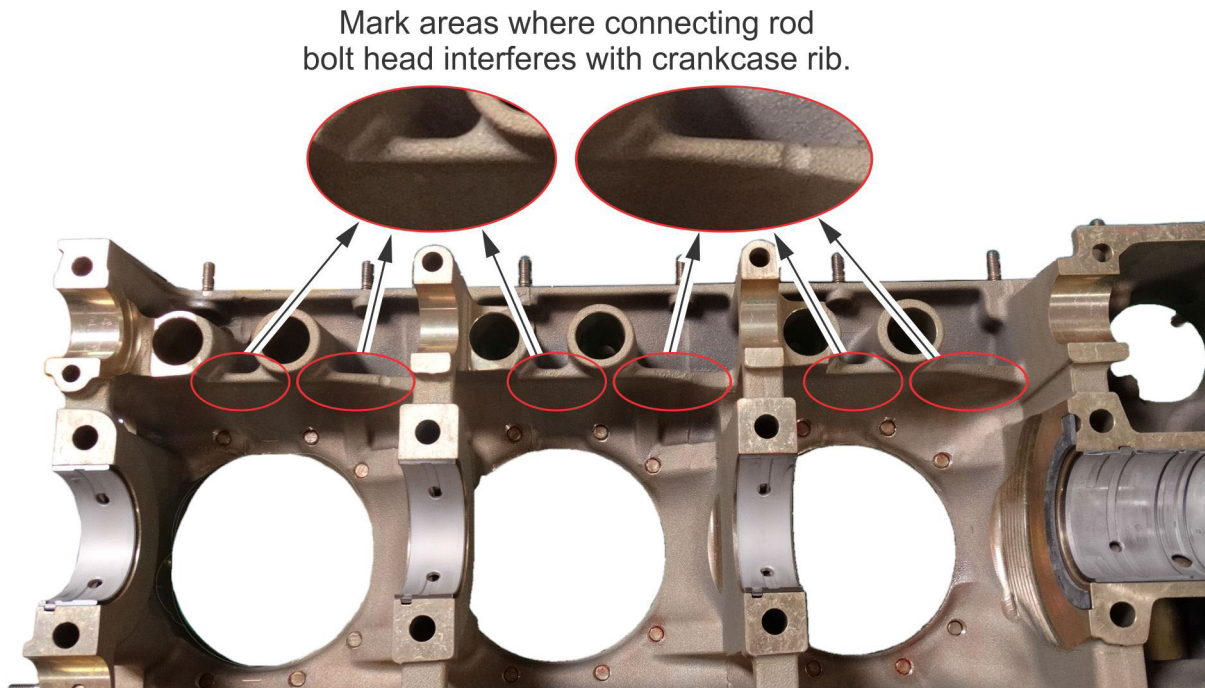
Continental Motors, Inc. (CMI) has received field reports of connecting rod bolt heads (P/N 655959) experiencing interference with the crankcase rib during engine drive train assembly on crankcases produced prior to 2011.

**Figure 4. Connecting Rod Bolt Head Clearance Areas, 1-3-5 side crankcase ribs**

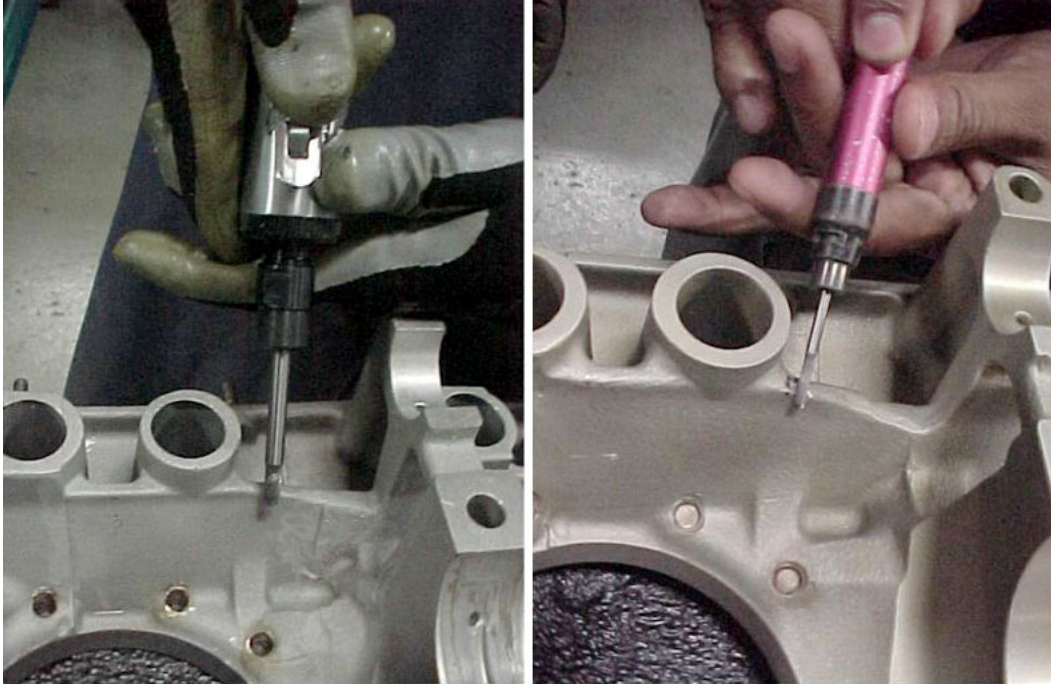
**Figure 5. Crankcase Clearance Modification, typical**

- Using a die grinder or pencil grinder, remove ONLY enough crankcase rib material from the marked crankcase to achieve connecting rod bolt head clearance of 0.020”-0.030” (see Figure 5).

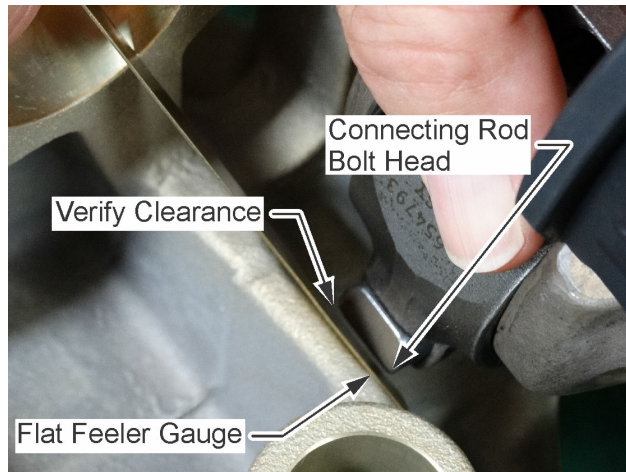
**Figure 6. Verify Clearance At All Interference Points, Feeler Gauge Measurement**

- Repeat Step 4 and Step 5 until clearance is achieved under all conditions. Using a flat feeler gauge, verify crankcase rib clearance of 0.020”-0.030” is provided for all connecting rod bolt heads (see Figure 6).

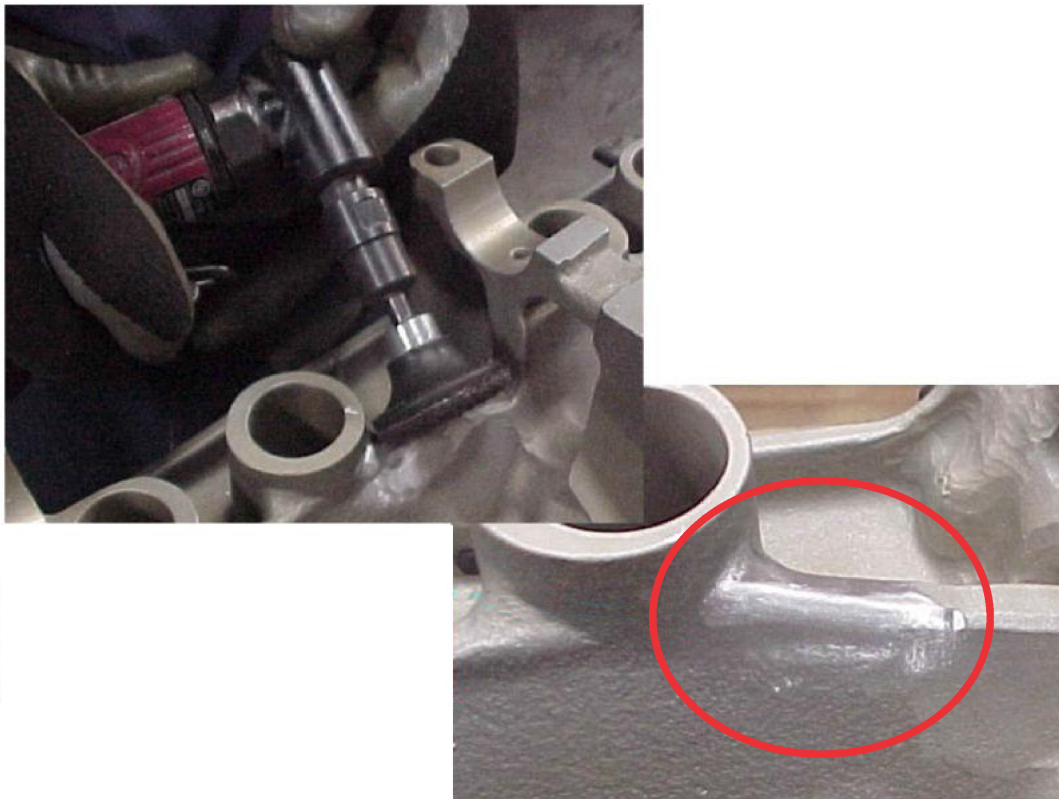
**Figure 7. Crankcase Finished Surface, deburring**

7. Inspect the crankcase clearance surfaces and remove all nicks, burrs, sharp angles or edges using a de-burring tool and Scotch-Brite® wheel (ultra fine or equivalent). Evenly shape, taper, and smooth all interfering crankcase rib surfaces where material was removed (see Figure 7).
8. Clean crankcase to remove all burrs and metal shavings.
