# SERVICE No. 905 BULLETIN

Piper Aircraft Corporation  
Vero Beach, Florida, U.S.A.

SUBJECT: Auxiliary Primer Switch Replacement

PA-28-201T Turbo Dakota	28-7921001 through 28-7921091
PA-28R-201T Turbo Arrow III	28R-7703001 through 28R-7803373
PA-28RT-201T Turbo Arrow IV	28R-7931001 through 28R-8631005, 2831001 through 2831036
PA-34-200T Seneca II	34-7570001 through 34-8170092
PA-34-220T Seneca III	34-8133001 through 34-8633031, 3433001 through 3433089

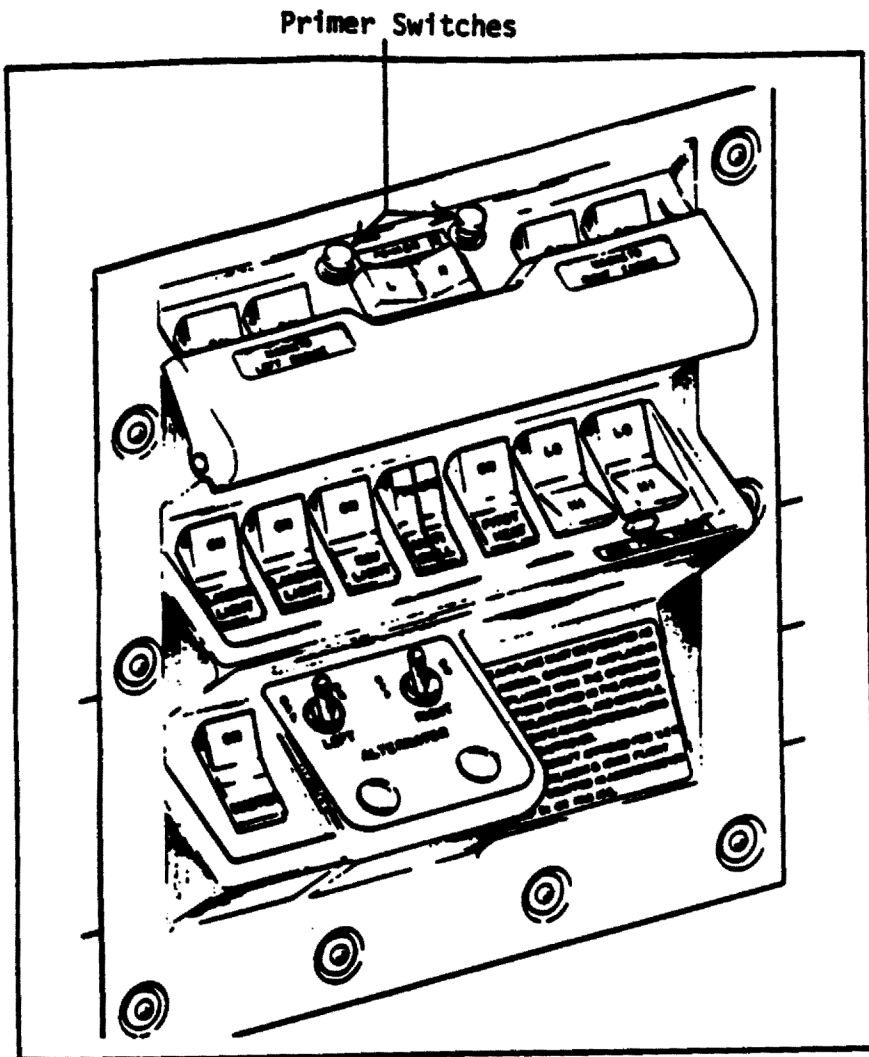
1. Disconnect the battery.
2. Locate the two auxiliary primer switch assemblies at the top of the switch panel to the left of the pilot's seat. See Figure 1 (attached).

Switch Panel - With Primer Switches

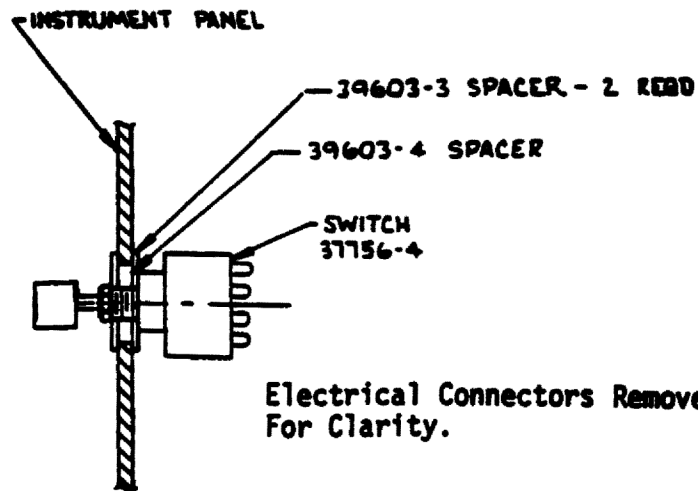
Figure 3

Electrical Connectors Removed  
For Clarity.

4. To install two new Auxiliary Primer Switch Assemblies, Piper Part Number 37756-04: Connect the electrical connectors. When positioning the switch assemblies in their mounting holes use two (2) each Spacer, Piper Part Number 39603-03 and one (1) each Spacer, Piper Part Number 39603-04 per switch assembly as shown in Figure 3. Secure with the hardware supplied with each switch assembly.
5. Connect the battery.
6. Perform a functional check of the primer system.
7. Make an appropriate logbook entry of compliance with this Service Bulletin.
