Piper Aircraft Corporation  
Vero Beach, Florida, U.S.A.

# SERVICE No. 938 BULLETIN

Date JUNE 12, 1990

SUBJECT: Wire Protection

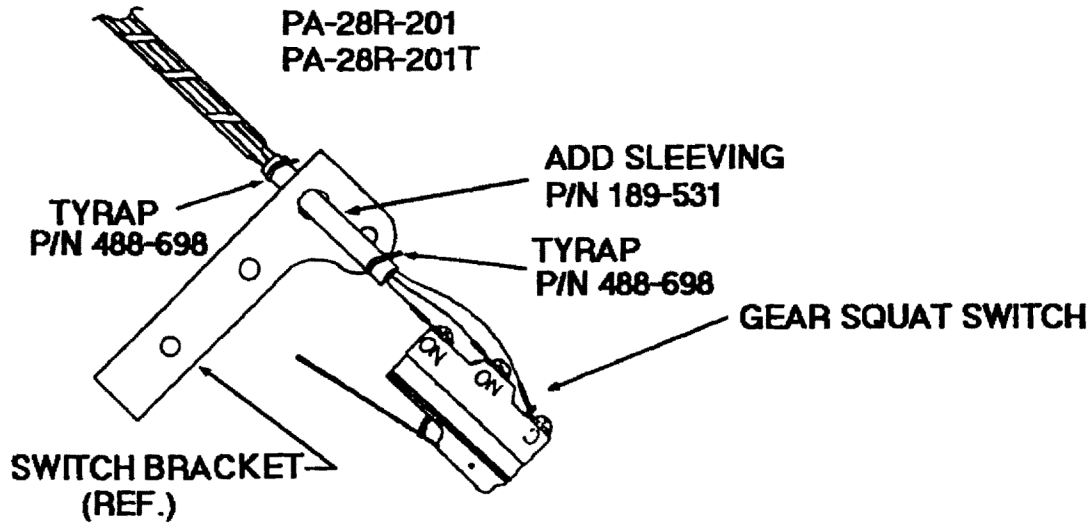
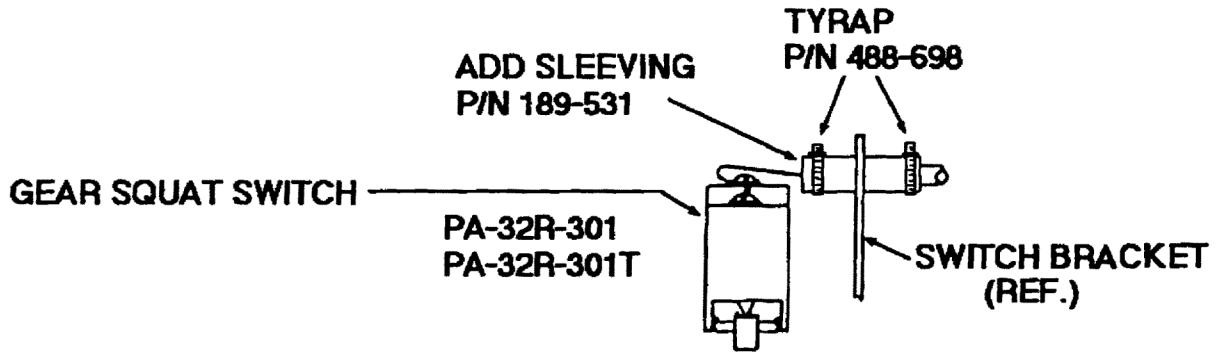
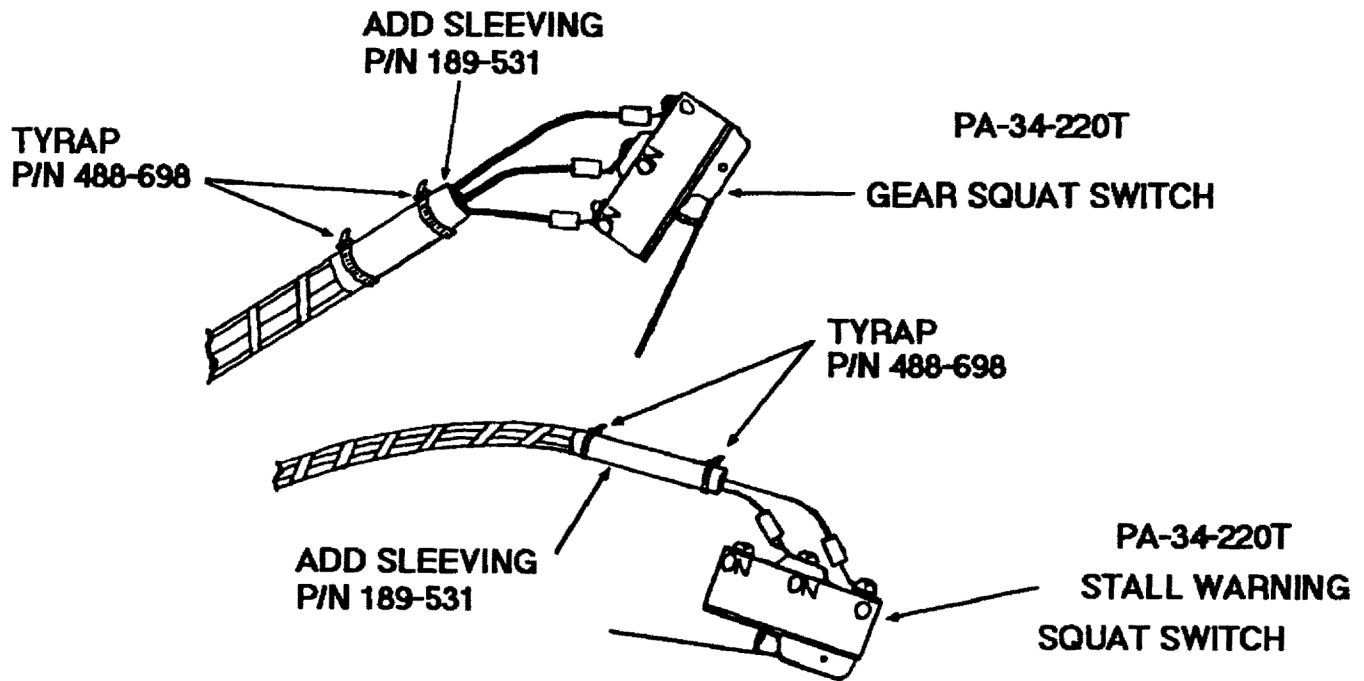
SKETCH "A"

PURPOSE: Piper Aircraft has learned of a possible chafing condition affecting the wire harness to the left main landing gear squat switch and stall warning micro switch. If left uncorrected, this condition could result in failure of the two systems.

5. With wires from switch removed, install protective sleeving over wires using Tyrap, Piper Part Number 488-698, to secure sleeving in place as shown in Sketch "A" attached.

NOTE: When sleeving is secured, care should be exercised not to add any undue stress to wire/terminal when attaching to switch.
