Piper Aircraft Corporation
Vero Beach, Florida, U.S.A.

SERVICE No. 940A BULLETIN

<u>SUBJECT:</u>	Throttle Microswitch
<u>REASON FOR REVISION:</u>	To Correct Material Required
<u>MODELS AFFECTED:</u>	<u>SERIAL NUMBERS AFFECTED:</u>
PA-28R-180 Arrow	28R-30001 through 28R-7130013
PA-28R-200 Arrow/Arrow II	28R-35001 through 28R-7635545
PA-28R-201 Arrow III/Arrow	28R-7737001 through 28R-7837317 and 2837001 through 2837035, 2837038 through 2837050
PA-28R-201T Turbo Arrow III/Turbo Arrow	28R-7703001 through 28R-7803372 and 2803001 through 2803012
PA-28RT-201 Arrow IV	28R-7918001 through 28R-8218026
PA-28RT-201T Turbo Arrow IV	28R-7931001 through 28R-8631005 and 2831001 through 2831038

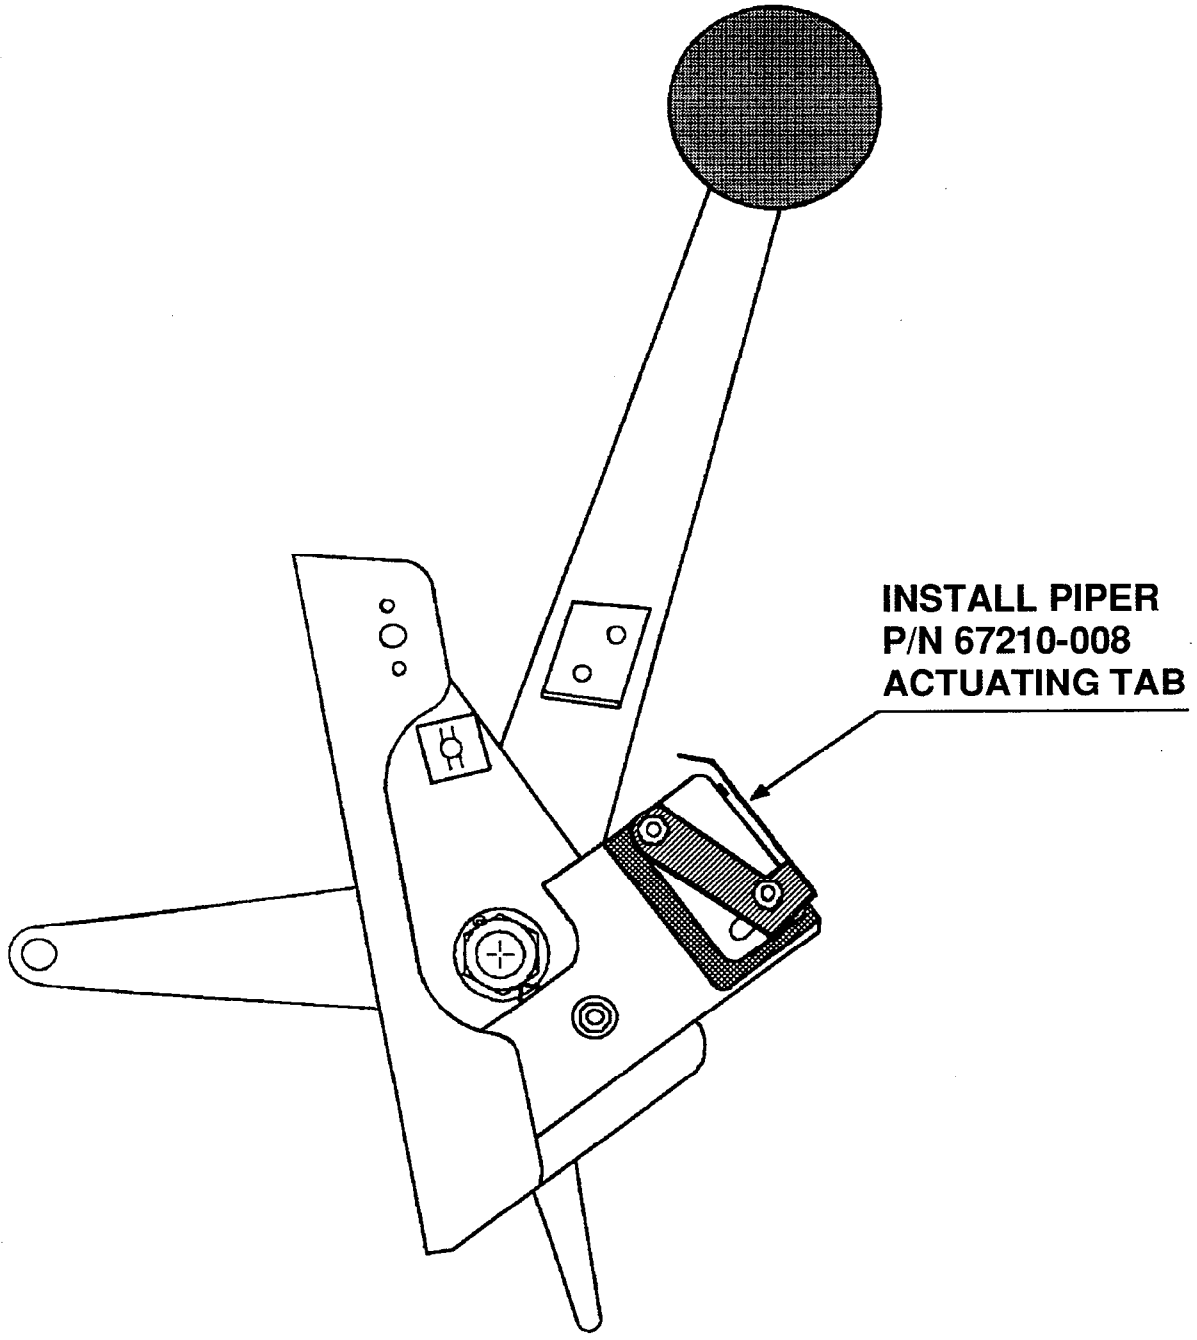
PURPOSE: Piper Aircraft has determined that a condition exists under extremely heavy usage, which could result in breakage of the throttle actuated gear warning horn microswitch. This condition, if left uncorrected, will result in the failure of the gear warning horn to sound, or the possibility of an electrical short which will cause the horn to sound continuously.

9. Install Actuator Arm, Piper Part Number 67210-008, onto the throttle microswitch as shown in Sketch A.
10. Move the throttle forward and aft, ascertain that the switch actuates.
