**The New Piper Aircraft, Inc.**  
2926 Piper Drive  
Vero Beach, Florida, U.S.A. 32960

# SERVICE *No.* 1023 BULLETIN

**Inspection of Landing Gear Cylinders and  
Distribution of Parker Hannifin Service  
Bulletin SB7063**

## LANDING GEAR – RETRACT CYLINDER - INSPECT / REPLACE

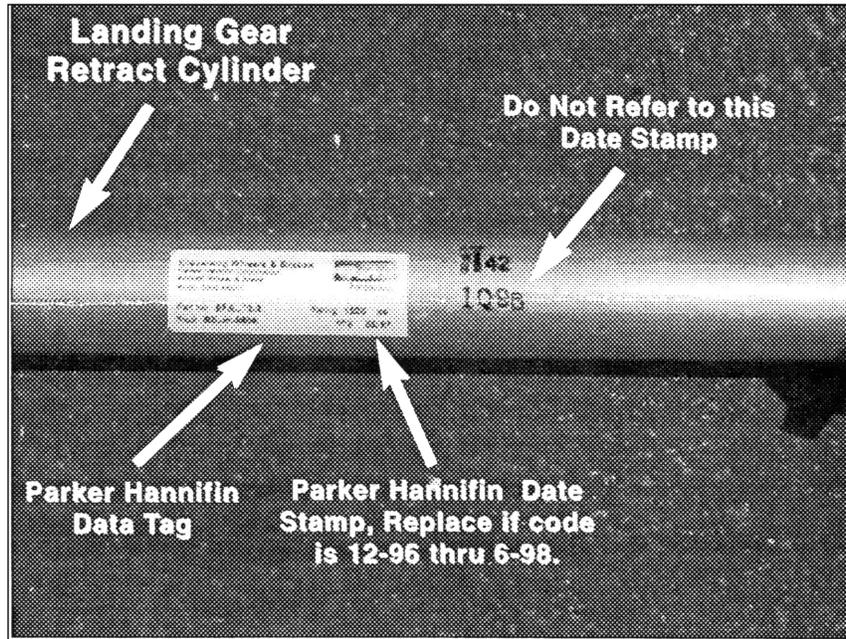
**Typical Landing Gear Cylinder  
Fig. 1**

3. Gain access to the main and nose hydraulic landing gear cylinders and locate the data tag. A date of manufacture is stamped or printed on the tag. (See Fig. 1.)

4. Referring to the Parker Hannifin Service Bulletin for identification, the cylinders to be replaced will have date stamps **12-96** through **6-98**. Cylinders with date stamps before or after are not affected.

Landing Gear Cylinder Data Tag Location  
Piper P/N 96860-02 (Parker P/N SFA232-5 or 11-5D)
