# SERVICE No. 1026 BULLETIN

**Distribution of Parker Hannifin Airborne Service Letter 48, "Inspection/Replacement of dry air pump flexible couplings".**

**Service Letter Number:** 48

**Subject:** Inspection/Replacement of dry air pump flexible couplings.

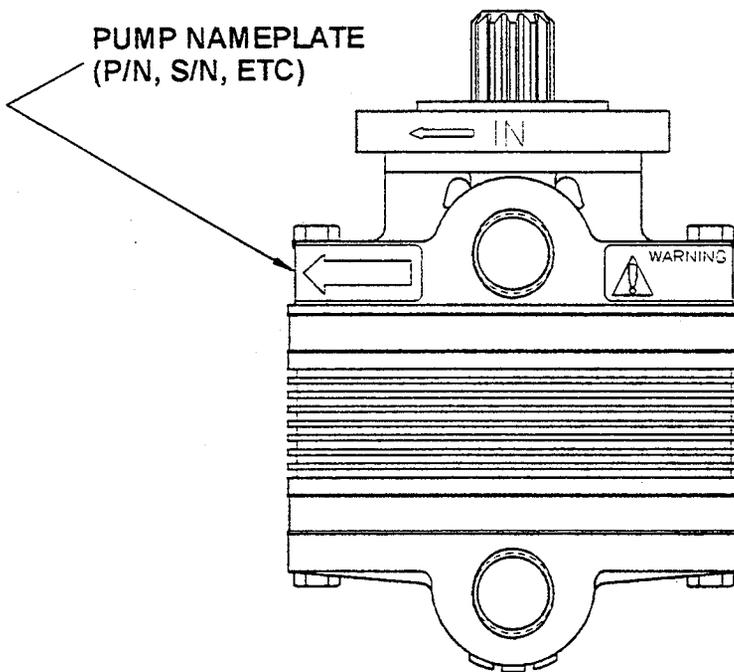
FIGURE 1

**Applicability:** Airborne dry air pumps, conversion kits and flexible coupling kits with the following part numbers/serial numbers which have not been inspected per this service letter as identified in step number seven of the procedure listed below. These components were shipped from Airborne between 1/1/98 and 10/13/98. Refer to Figure 1 for location of part number/serial number nameplate.
