Piper Aircraft, Inc.
2926 Piper Drive
Vero Beach, FL, U.S.A. 32960

SERVICE NO. 1331A BULLETIN

STABILATOR IDLER ARM ASSEMBLY INSPECTION

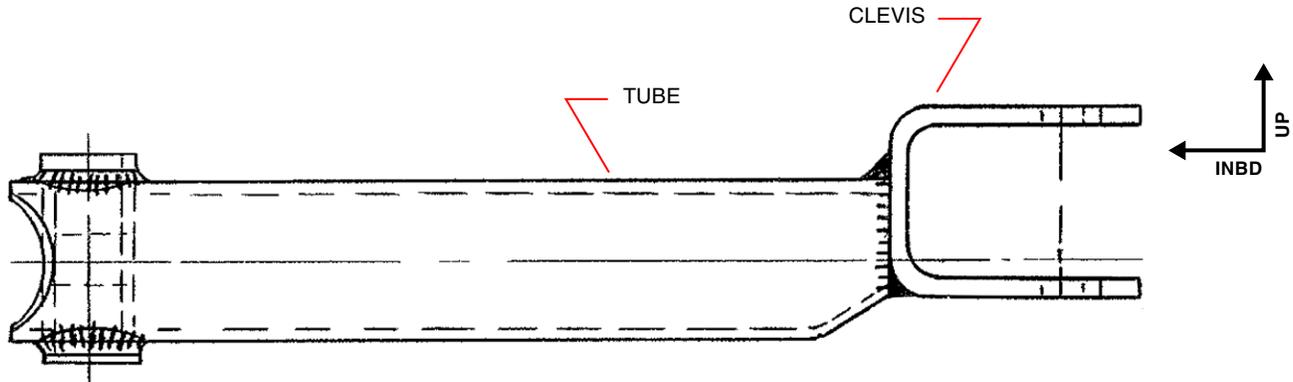
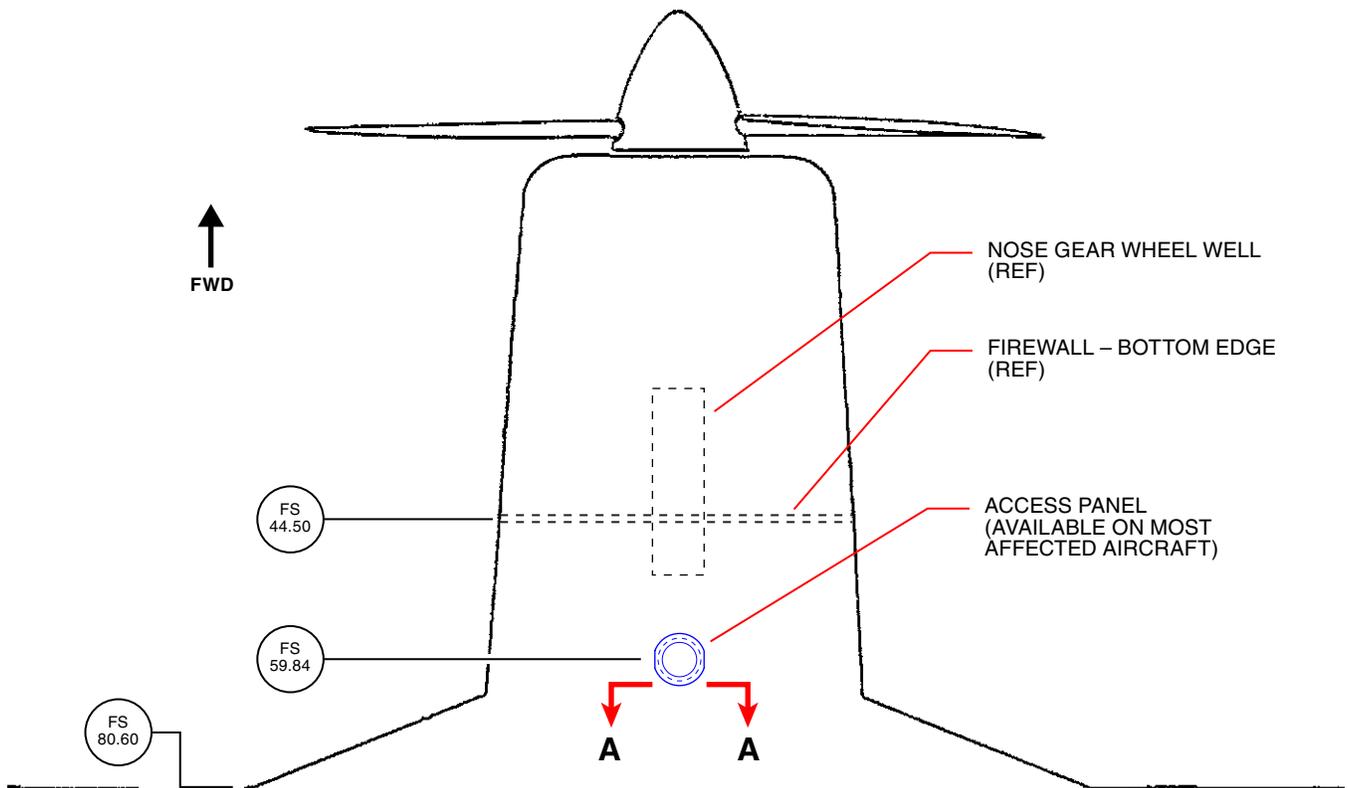
Figure 1
Stabilator Idler Arm Assembly Location

1. Remove the circular access panel that is directly aft of the nose gear wheel well opening, as shown in Figure 1.
NOTE: Some of the affected models do not have the access panel shown in Figure 1. For those aircraft, temporary removal of components on the top surface of the tunnel will provide access for this inspection.

2. Looking aft through the tunnel, examine the orientation of the Stabilator Idler Arm Assembly, Piper part number (P/N) 67066-000, and compare that to the orientation of the part in Figure 1, View A–A, and Figure 2, which shows P/N 67066-000 correctly installed. A properly installed P/N 67066-000 will have the clevis positioned above the tube.

STABILATOR IDLER ARM, P/N 67066-000
CORRECT ORIENTATION AS INSTALLED
LOOKING AFT

- 2) Remove P/N 67066-000 and reinstall it in the proper orientation, per the appropriate Piper Airplane Maintenance Manual, Section 27-30-00, or Service Manual, Section V.
