SERVICE LETTER

No. 718

Subject: Bendix Magneto Bulletin No. 566 -- reference attached Avco Lycoming Service Bulletin No. 373, dated March 22, 1974.

SUBJECT: S-1200 Distributor Block and Gear Change

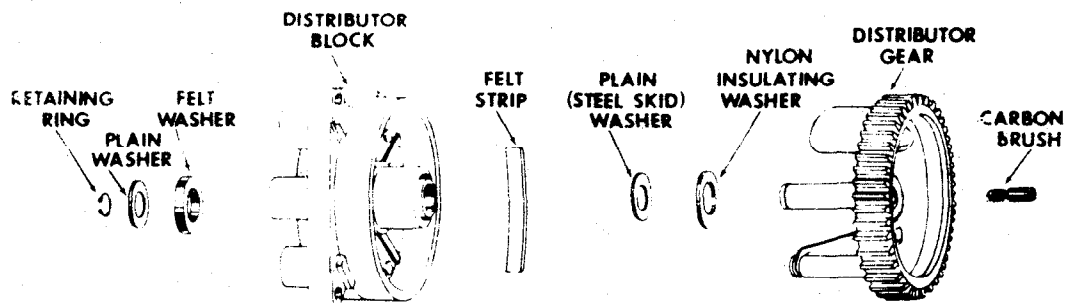
Figure 1.

Detailed Instructions:
 It has been found that the addition of a nylon insulating washer and steel skid washer between the distributor gear electrode and the block bushing, as shown in figure 1, reduces the possibility of deterioration of the lubricant and possible seizure of the parts.

Assemble large distributor gear, nylon and steel washers to new or reworked block as follows using figure 1 as a guide.

Once modified, the distributor block can be used only with a gear having the nylon and steel washer installed over the shaft as shown in figure 1.

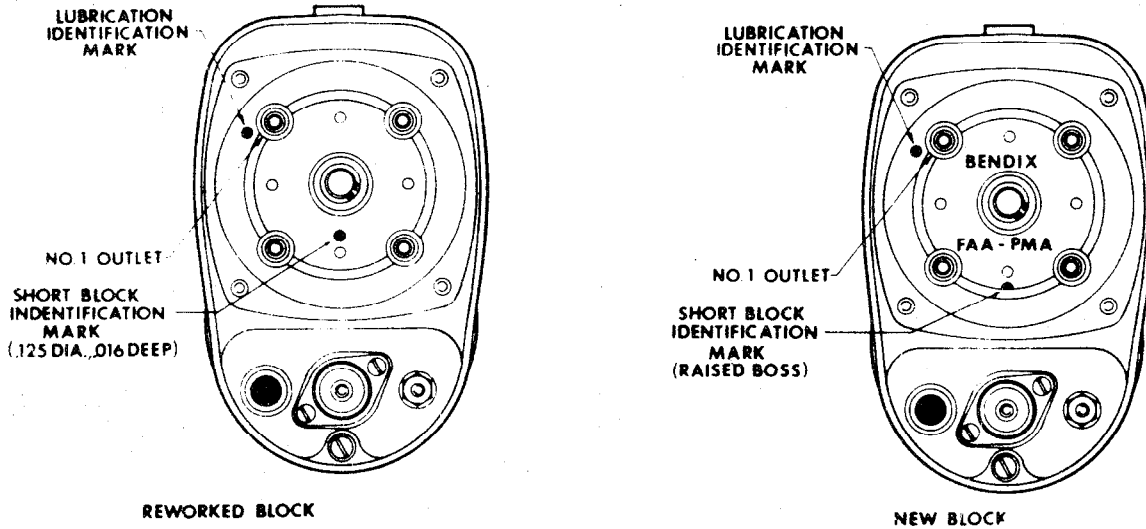
Figure 2

boss between the high tension towers at the six o'clock position and molded in letters as shown in figure 2. Reworked blocks are identified by a drill point indentation in the same location. New and reworked blocks both have different part numbers from the current (old) block. See Table 1.

7. Identify reworked blocks by drilling a flat bottomed hole .125" diameter and .016" deep in the six o'clock position as shown in figure 2.

(3) Identify distributor block by drilling flat bottomed indentation 0.125 inch diameter and 0.016 inch deep located as shown in figure 2.
