SERVICE LETTER

No. 814

Piper Aircraft Corporation

Subject: Cherokee Arrow III & Turbo Arrow III Refinement Program

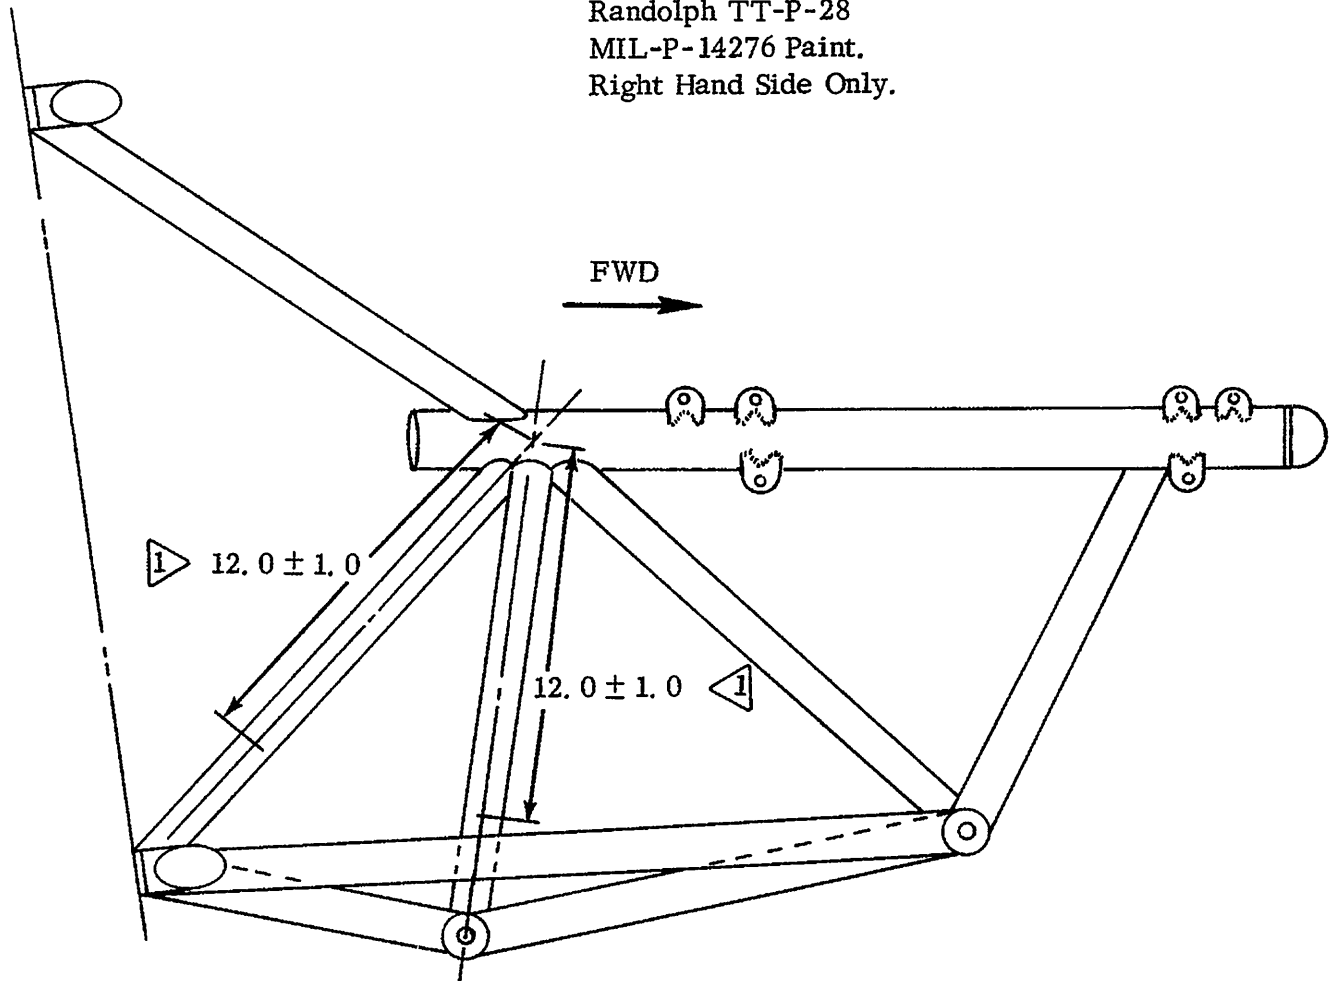
RIGHT SIDE VIEW OF ENGINE MOUNT

Purpose: It has been found that the engine mount paint in the area where the exhaust stack is in close proximity to the engine mount on the right hand side was deteriorating because of heat. This Service Release furnishes instructions for repainting a portion of the engine mount with a heat resistant paint.

1 Clean Area Noted
and Paint With
Randolph TT-P-28
MIL-P-14276 Paint.
Right Hand Side Only.

1. Refer to Sketch "A" and completely remove all of the black paint in the area shown.

- 2. Repaint the area from where the paint was removed with the high temperature paint listed in Material Required below.

Material Required: High temperature paint Piper Part No. 763 415V, Randolph number TT-P-28 (MIL-P-14276) @ suggested unit list price \$ 4.88G.
