# SERVICE LETTER

No. 861

Piper Aircraft Corporation

Subject: Forward Facing Seat Back Modification

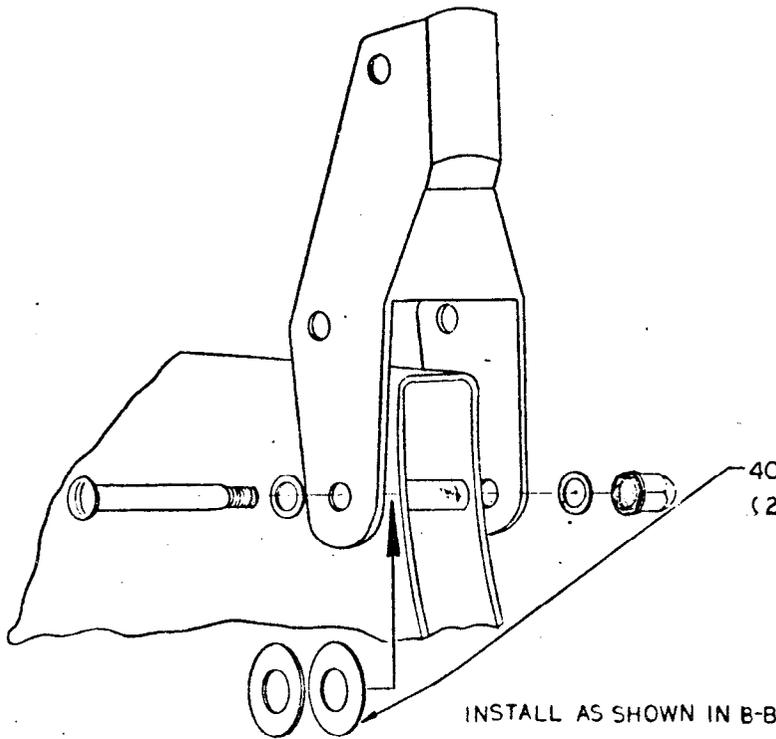
DETAIL A

This Service Release announces the availability of an improved method of retaining the rear facing (club) seat backs in an up-right position. Friction washers are installed at the seat back hinge in lieu of the existing clips on the above affected aircraft.

408-834  
(2 REQ)

Four(4) each Piper Part Number 408 834V Washers, friction per seat (eight (8) per aircraft) at a suggested list price of \$ .33C each.

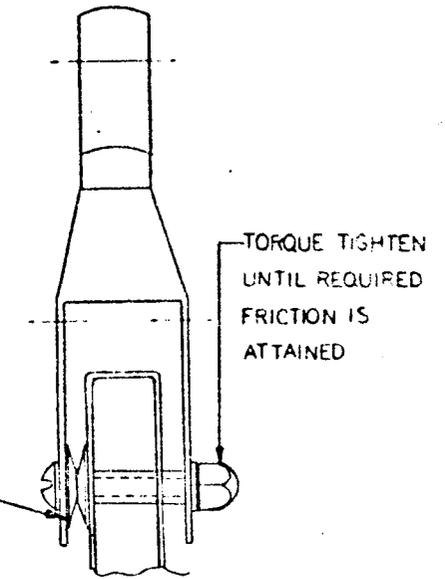
VIEW B-B

L.H. SIDE SHOWN  
R.H. SIDE OPPOSITE
