Piper Aircraft, Inc.
2926 Piper Drive
Vero Beach, Florida, U.S.A. 32960

SERVICE NO. 1125 LETTER

Date: July 27, 2010

STALL HORN BRACKET REPLACEMENT

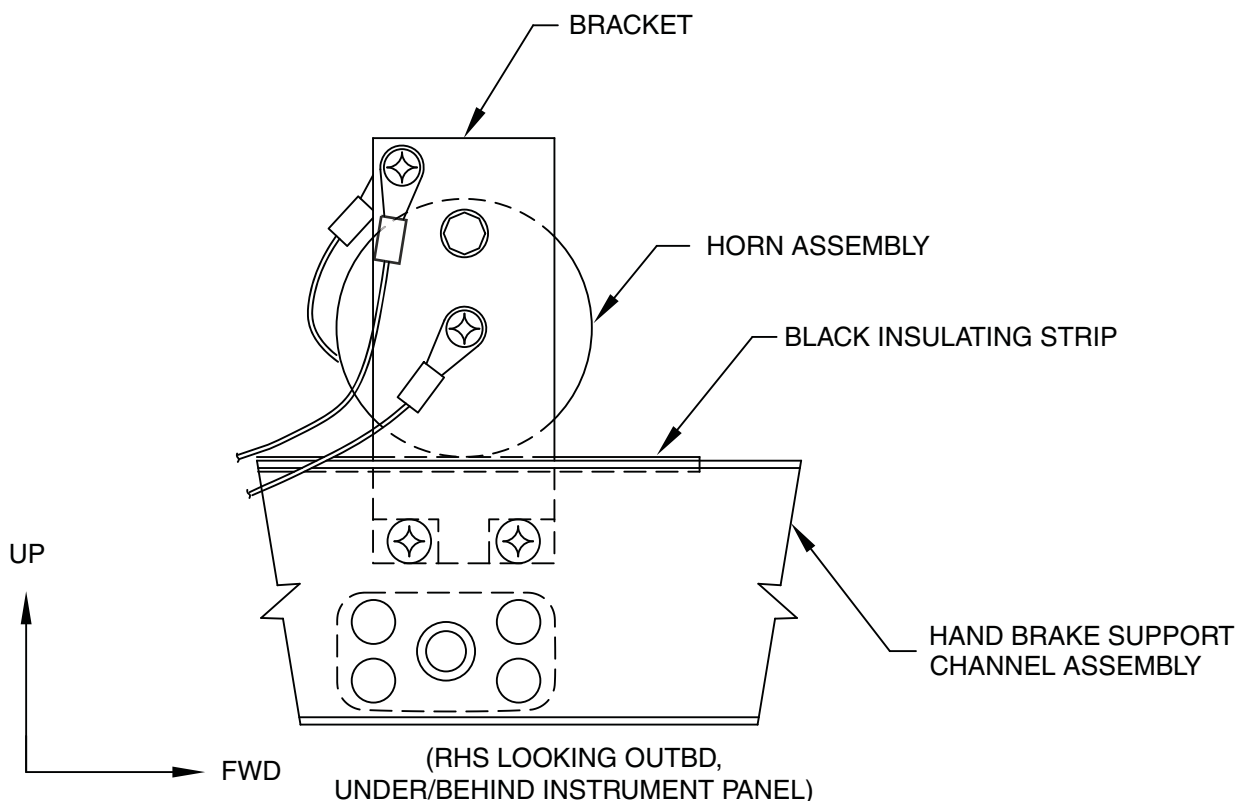
Figure 1
STALL WARNING HORN INSTALLATION (Typical)

Under certain conditions, the body of the stall warning horn may contact the hand brake support channel assembly, creating an electrical short circuit, which will trip the circuit breaker and render the stall warning alarm inoperable.

For aircraft operators that experience the stall warning circuit breaker tripping unexpectedly, a likely cause of this condition may be that the horn assembly is making intermittent contact with the hand brake support channel assembly. Proceed as follows to verify this condition:

1. Remove electrical power from the aircraft.
2. Locate the stall warning horn assembly, which is mounted on the hand brake support channel assembly, midway between the firewall and the instrument panel as shown in Figure 1.
3. The Bracket 35203-002 is made from phenolic, and is somewhat flexible. Apply gentle hand pressure on the horn assembly, in the direction to allow the horn assembly to contact the flange of the hand brake support channel assembly.
4. Examine the area of contact. There is a black plastic insulating strip mounted on the flange of the hand brake support channel assembly. If the insulating strip does not prevent contact between the horn assembly and the hand brake support channel assembly, order and install "STALL HORN BRACKET REPLACEMENT KIT", Piper part number 88472-002.
5. Make a logbook entry indicating compliance with this Service Letter.
