SERVICE NO. 1229 LETTER

Date: January 3, 2019

MAINTENANCE ALERT

CONTROL QUADRANT INSPECTION

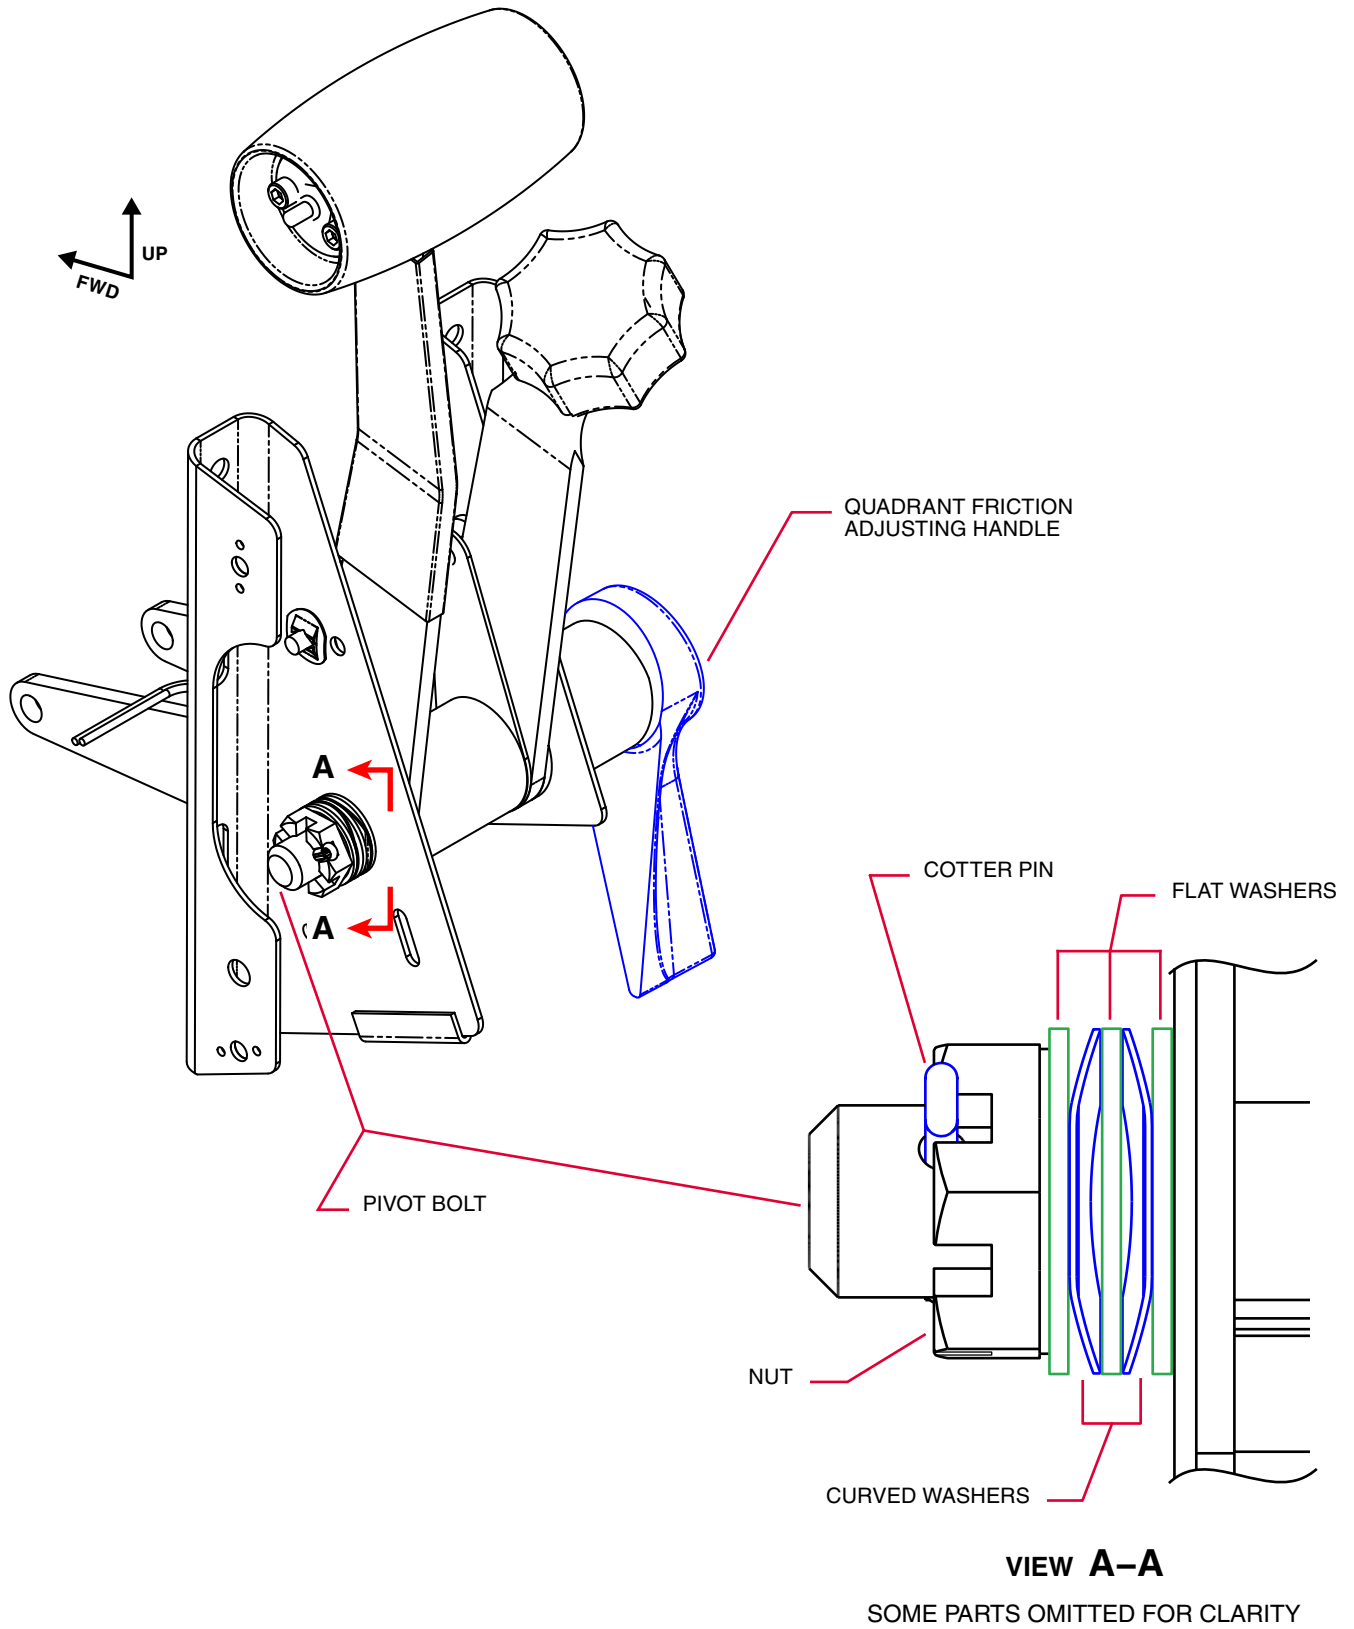
Figure 1
Control Quadrant Assembly With Cover Removed

The instructions in this maintenance alert should be followed if the quadrant friction adjusting handle is difficult to operate, or whenever the control quadrant is serviced.

4. Inspect the bolt that the levers pivot around and locate the stack of five (5) washers at the end of the bolt.
5. Compare the washer stack to Figure 1. There should be two (2) curved washers and three (3) flat washers. The configuration of these washers (their order, and the direction of the curved washers) must match the configuration shown in Figure 1.

NOTE: Depending upon the specific aircraft model, there may be additional components on the bolt, such as additional washers or a propeller lever, compared to what is shown in Figure 1. However, all affected aircraft will have the same basic configuration of five (5) washers in the assembly. Refer to the applicable Piper IPC for additional clarification.

6. If the stack of washers does not match Figure 1:

- Remove the cotter pin and nut from the end of the bolt. Retain the nut; discard the cotter pin.
- Rearrange the washer configuration to conform to Figure 1.
- As required to attain the proper, spring-loaded operation of the adjusting handle, add more flat washers on either side of this five (5) washer combination.

- Reinstall the washers and nut; install a new cotter pin at the end of the bolt. (Refer to Figure 1.)
