SERVICE No.638 BULLETIN

Piper Aircraft Corporation

Inspection of Fuel Line Union Fittings

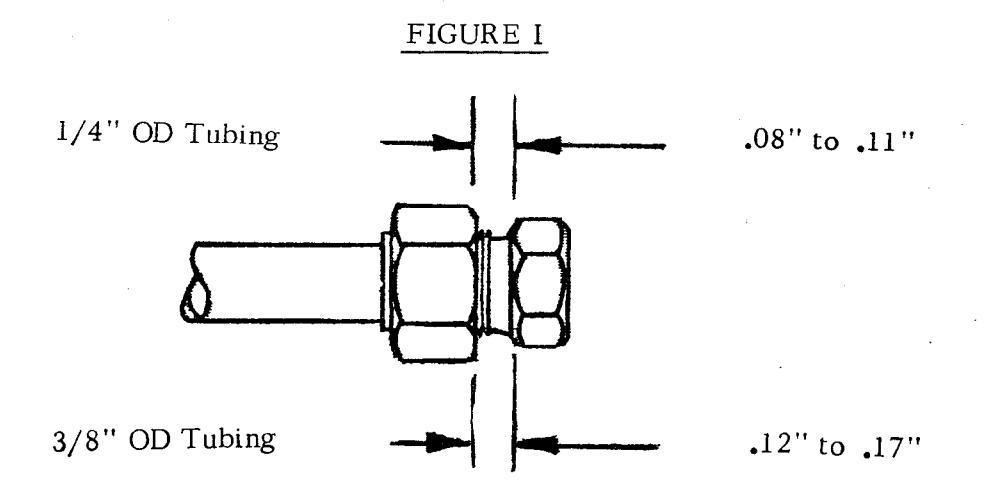
After the torquing of each fitting, measure the distance between the face of union nut and face of the tubing nut. See Figure I for tolerance.

If any fittings are found to be out of tolerance, refer to Part B, below. After all of the unions have been checked for proper tightness and all repairs (if required) have been made, insure that the airplane if full of fuel and run engine for three (3) to five (5) minutes on each tank.

- If the fitting shows evidence of galling, or does not meet the dimensional requirements of Figure I above, or continues to leak after being tightened, as outlines in Part A, item 5, above, it shall be repaired using items 2, 3, or 4, below.
- The recommended repair is to remove the leaking union and replace it using a standard AN fitting as outlined in AC43.13-1. (1972 issue) Paragraph 392. This will require cutting off the swaged ferrule and adding a short length of tubing.
